Property Inspection Report

- Habit New Zealand Limited -

***Sample Report
1986 Weatherboard***

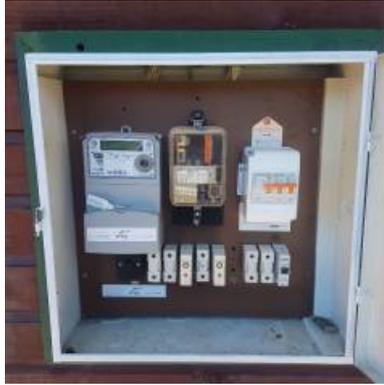
Mains power fuse board is found at the front of the dwelling.

Some modern fuses are installed here the rest are older style fuses. Due to the age and condition of the fuses we recommend a registered electrician further investigate as we do not conduct a full electrical inspection. If there are any fault this will be noted.

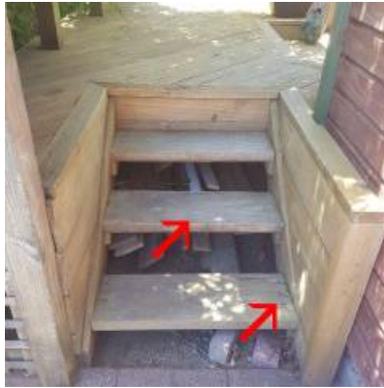
Exterior Stairs:

Timber, Reasonable Condition, Remedial attention suggested. Refixing required to the loose steps.

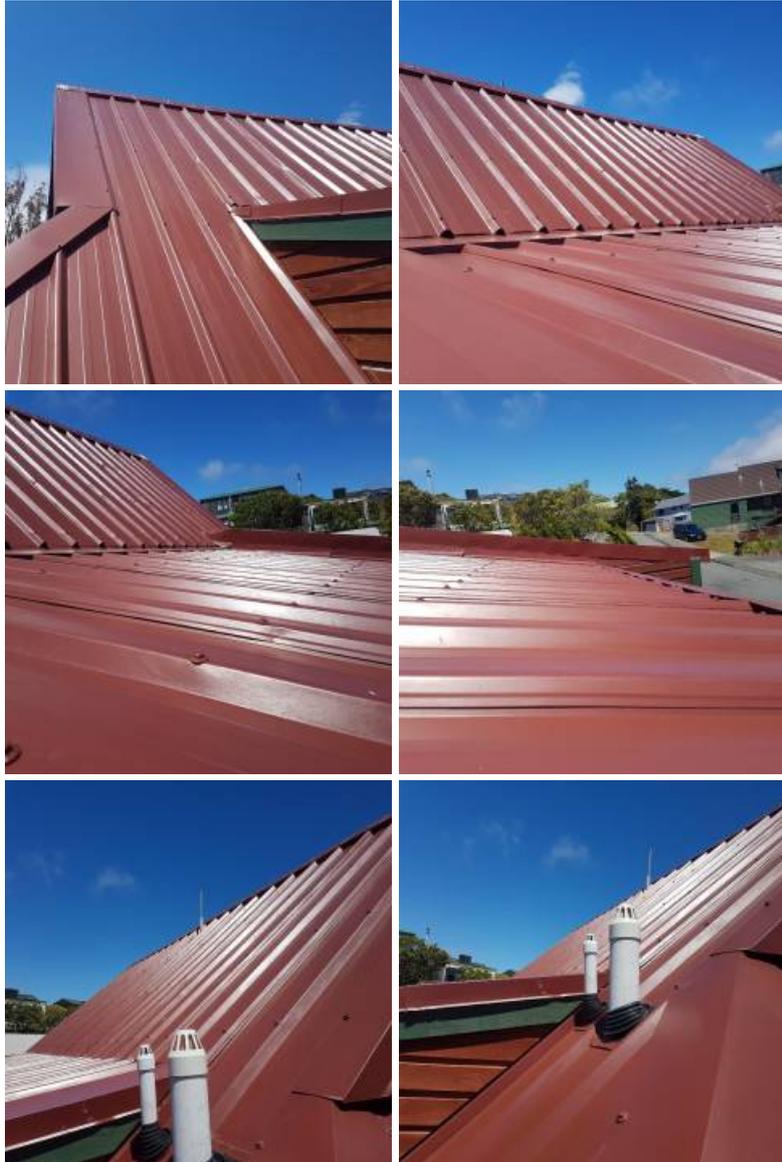
Painted long run iron. Some sheets with just evident, this can also be viewed from inside the roof space. The roof is nearing the end of its life expectancy and will require replacement in the near future. A licensed roofer is required to give you more information of time frames and costings.

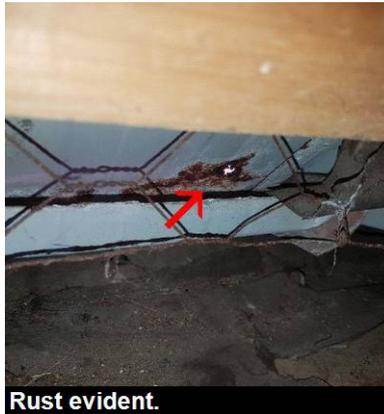
Rust evident.

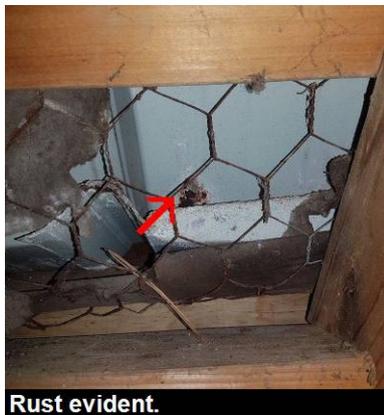
Rust evident.

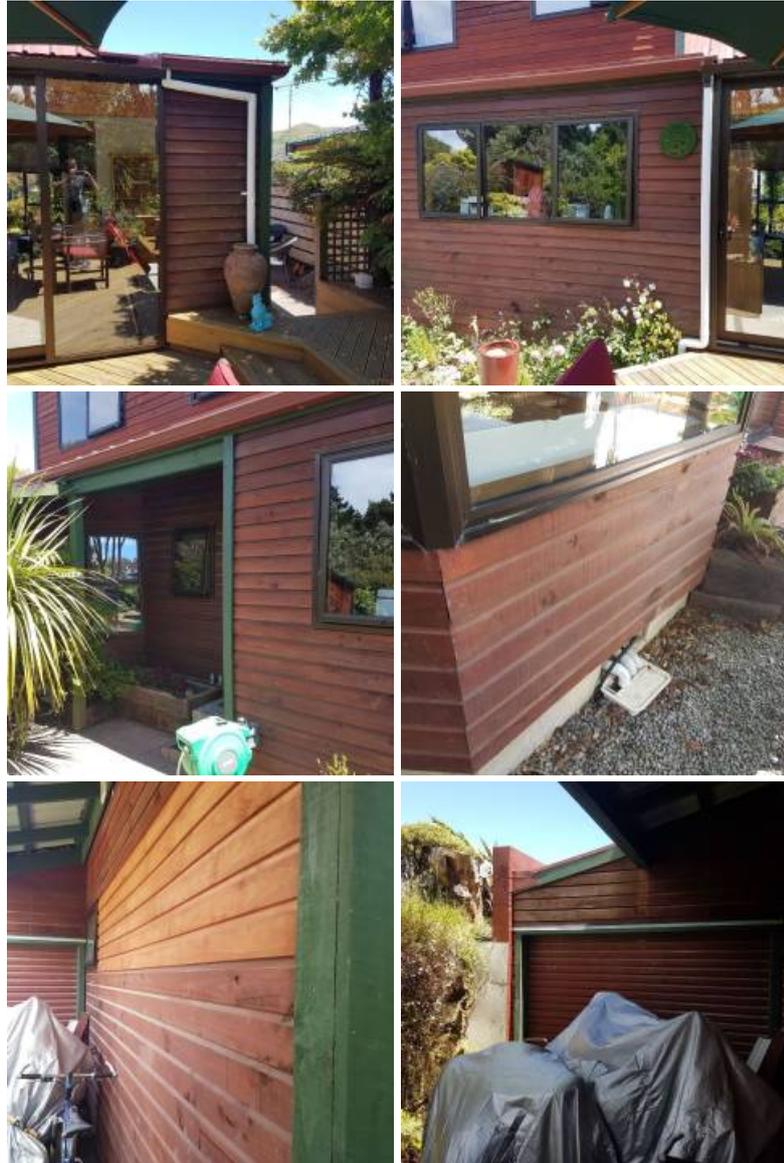
Ground Clearances

Insufficient ground clearance here, the clearance from the top of the finished ground height outside to the finished floor level inside, and to the bottom of the cladding is insufficient. This type of construction met the standards and regulations at the time of construction but is known to fail. This is a high risk design fault. This area has the potential to cause moisture ingress by capillary action when water sucks up between the wall cladding and framing. This area may have leaked in the past causing damage to the wall framing which cannot be viewed on our non invasive inspection. Further investigation is required. I suggest these ground heights are dropped and some form of drainage is installed to this area.

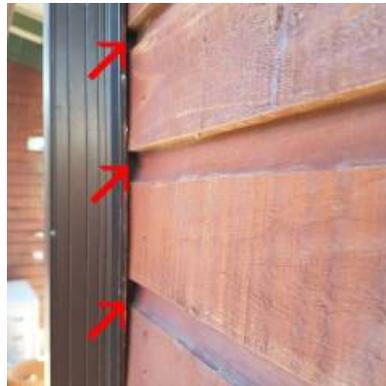
Remedial attention required, Timber chucks are required to be fitted down the sides of all joinery to prevent any moisture ingress.

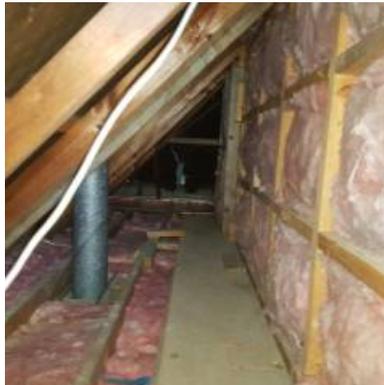
Lining paper, **Remedial required on the roof lining installed. Damaged and requires re-fixing, or re-placing.**

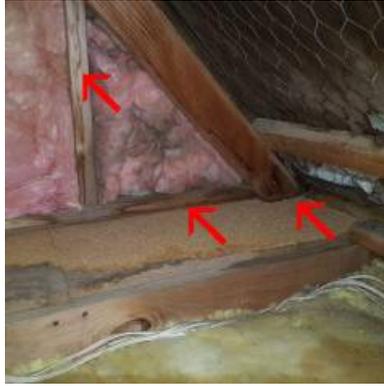
Water staining was viewed in the ceiling space. This may be due to old leaks, if it is not raining on the day of inspection we will not be sure of this. See the roofing section for any relevant information on the condition of the roof and if further attention is required in this area.
