Property Inspection Report

- Habit Blenheim -

SAMPLE PREMIUM REPORT

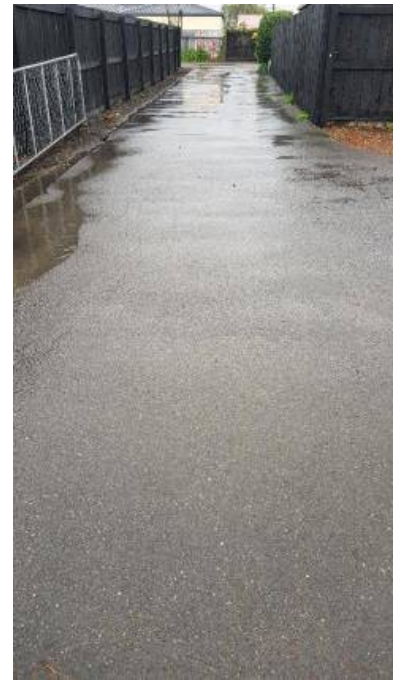
Remedial attention suggested. Surface upgrade suggested where the driveway is incomplete.

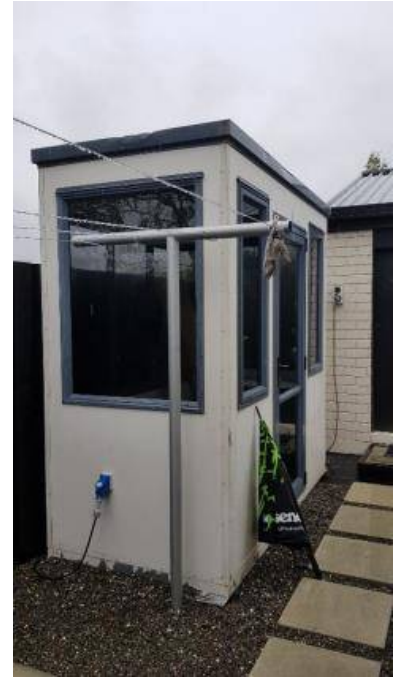
Image Site Area 3:

Outbuilding not inspected.

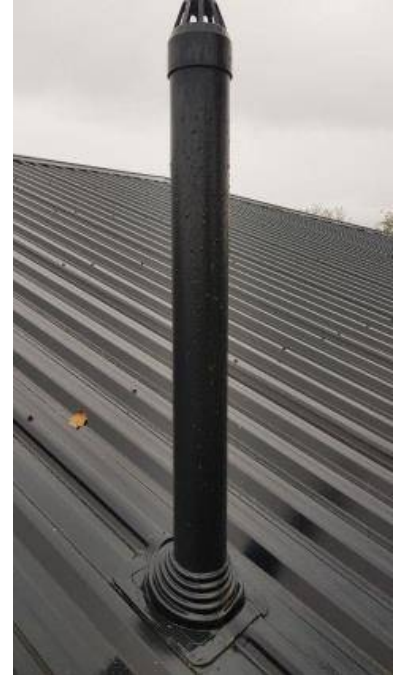
Outlet Pipes:

PVC, Reasonably well flashed, Material in, Good Condition. Remedial attention required
Minor sealing around base of the flashing required.

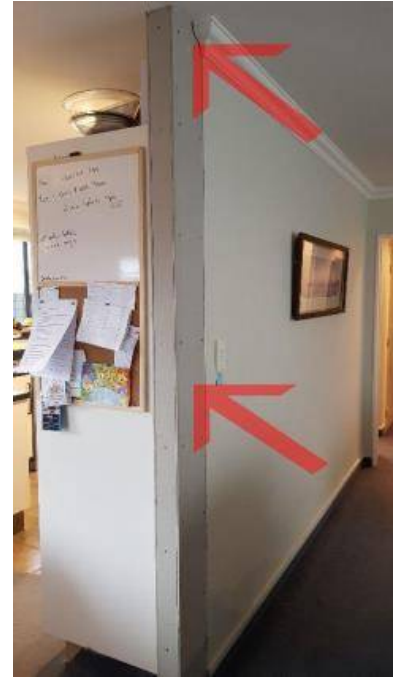
Base linings intact, Reasonable Condition, Remedial attention required, Cosmetic upgrade required where the wall has been slightly extended.

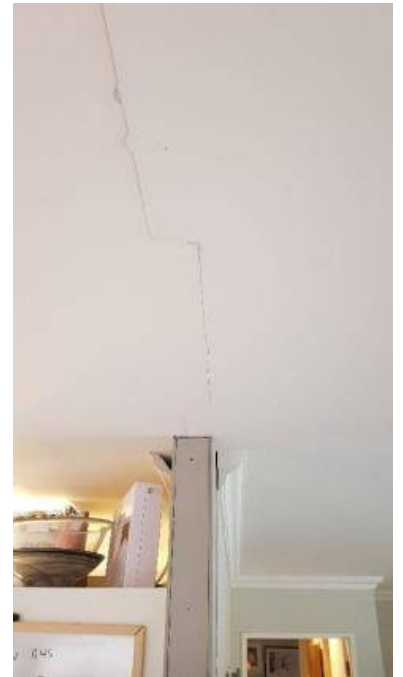
Internal inspection comments: The internal linings are in good sound condition. There is a crack noted in the dining room ceiling lining (not of a structural concern) and a small wing wall between the kitchen/lounge that require cosmetically addressing.

Cracking evident to the ceiling plaster join here. Not of a structural concern. Remedial attention required, Cosmetic upgrade required.

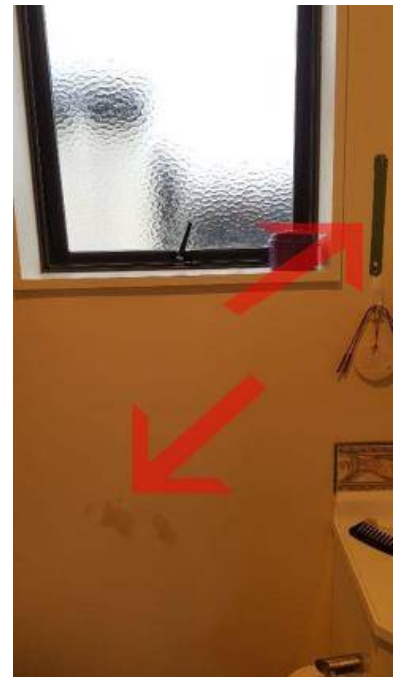
Base linings intact, Good Condition, Remedial attention suggested, Cosmetic upgrade required.

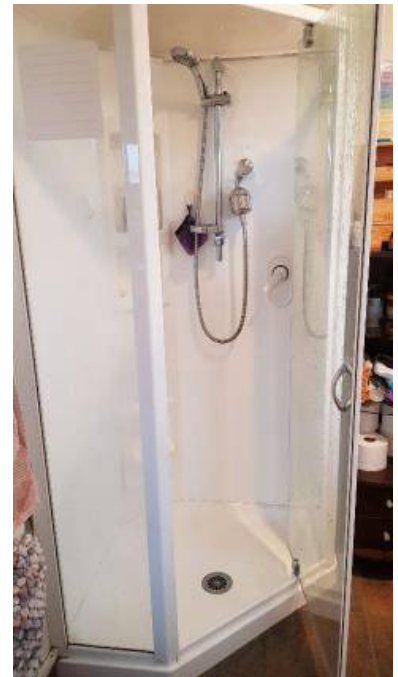
All wet areas were tested, good pressure found, no major leaks or blockages found however the ensuite shower has a minor leak that requires re-sealing.

Remedial attention required, Re-sealing required here.

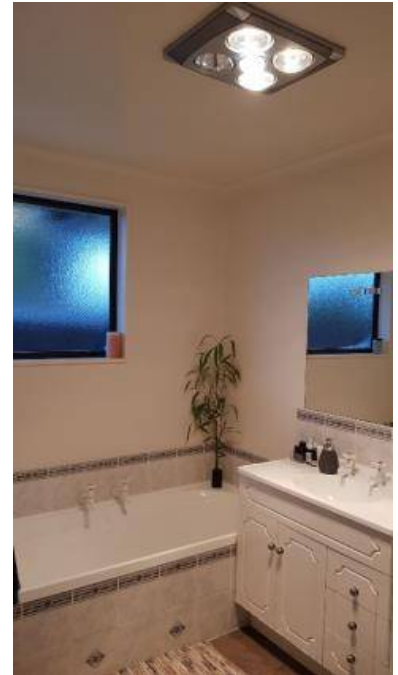
Minor cracking evident to the plaster join above the doorway, this is a common place where you will get movement, [Cosmetic upgrade suggested.](#)

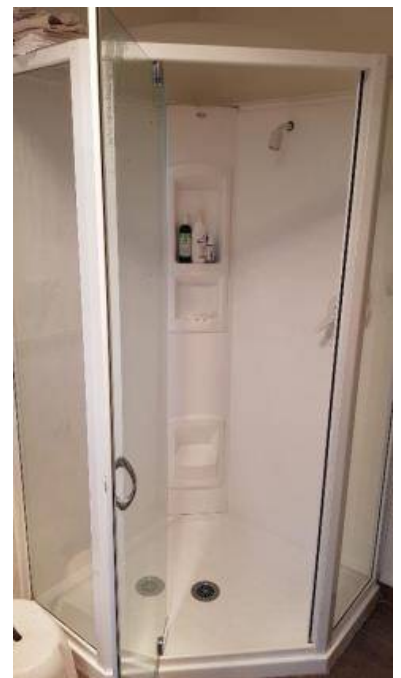
The mid section of the shower liner is not sealed back tight to the wall here. The shower appears watertight however in time be aware this liner may require re-glueing and sealing.

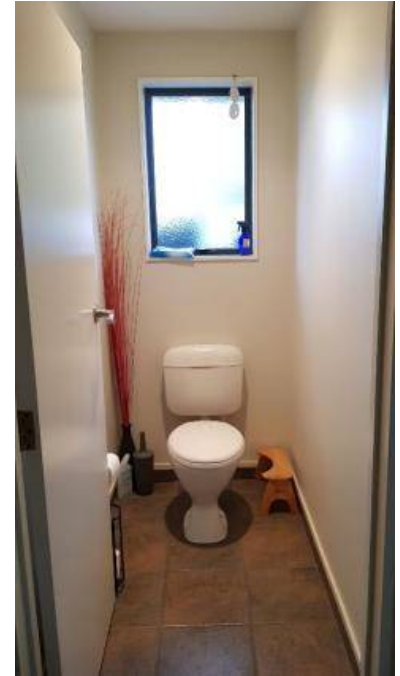
Minor cracking evident to the plaster joins next to the window, this is a common place where you will get movement, [Cosmetic upgrade suggested.](#)
