# Property Inspection Report

***- Habit Blenheim -***

***SAMPLE STANDARD REPORT***

## Inspection Details - Property Inspection Report

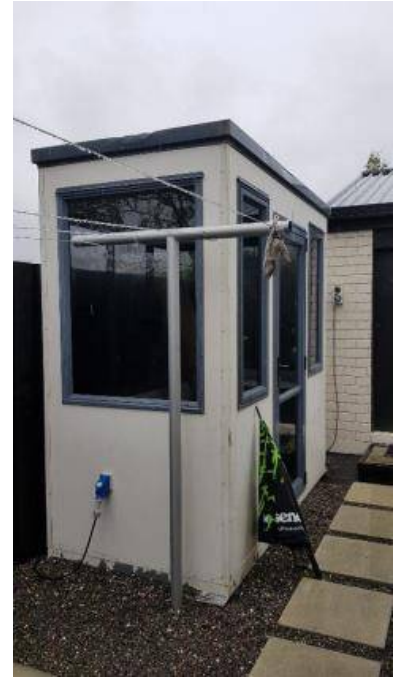
Image Site Area 3:

Outbuilding not inspected.

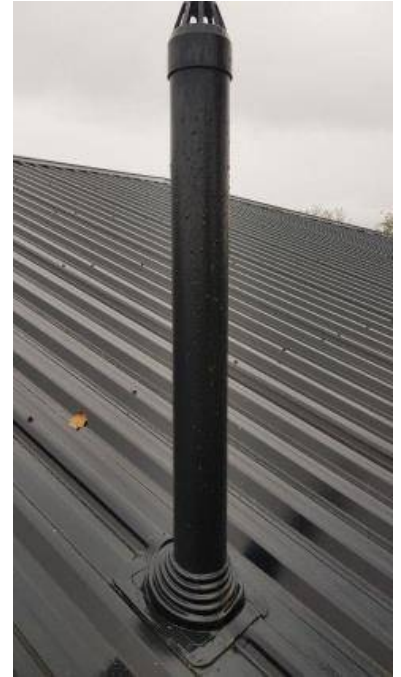
## Outlet Pipes:

PVC, Reasonably well flashed, Material in, Good Condition. Remedial attention required Minor sealing around base of the flashing required.

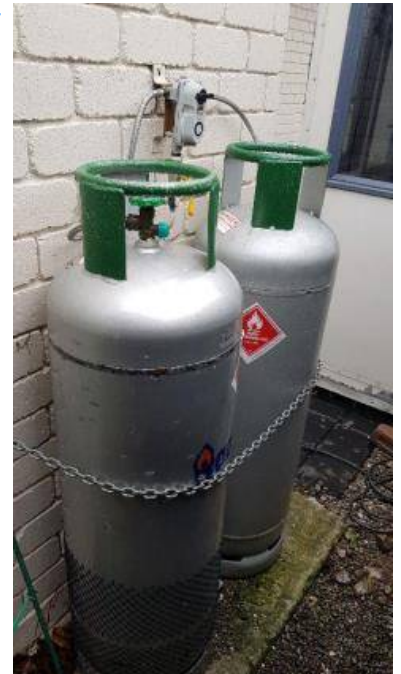
*Gas external connections:*

Gas installed. Not inspected, this is outside our scope. A gas certificate should be supplied and will be logged individually in the respective areas.

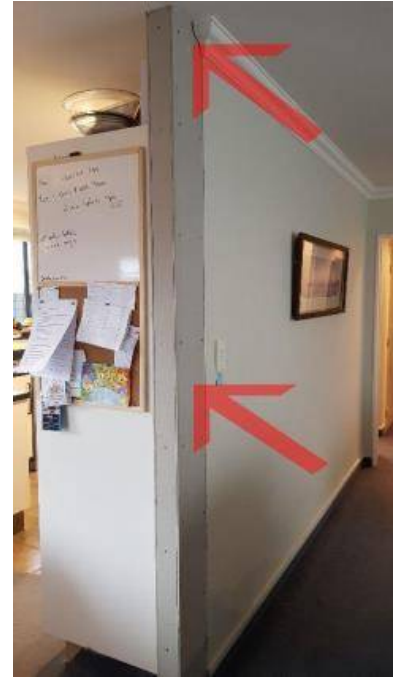
Cracking evident to the ceiling plaster join here. Not of a structural concern. Remedial attention required, Cosmetic upgrade required.

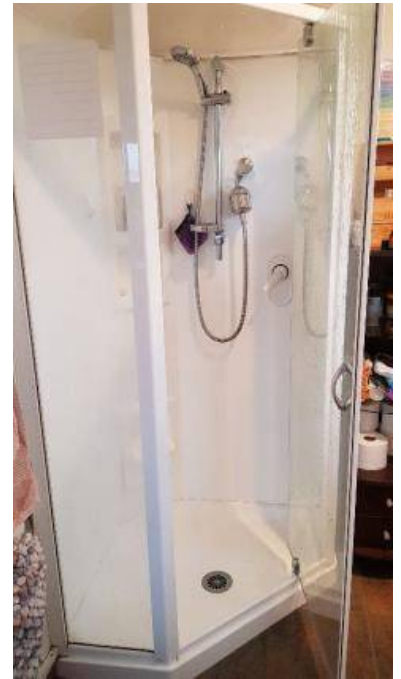
Remedial attention required, Re-sealing required here.

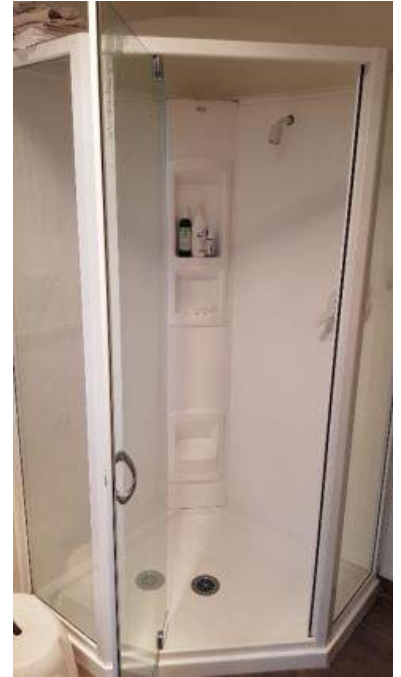
The mid section of the shower liner is not sealed back tight to the wall here. The shower appears watertight however in time be aware this liner may require re-glueing and sealing.

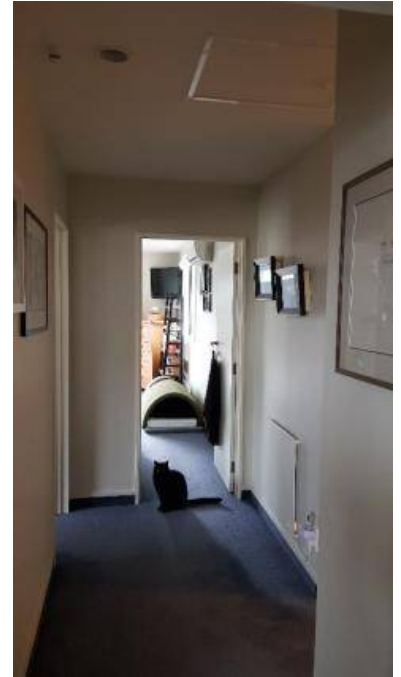
Minor cracking evident to the ceiling lining here, this is a common place where you will get movement, [Cosmetic upgrade suggested](#).

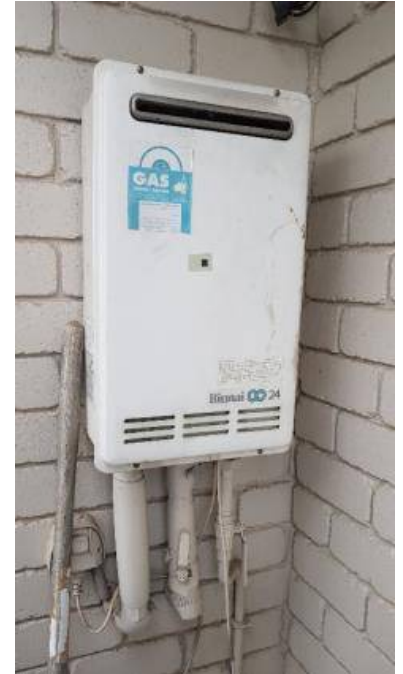
### Hot Water Heating System:

The connections evident appear to be in a reasonable condition. Natural signs of ageing, no sign of any major damage or moisture leaks evident here when inspected.

**Please note** we do not specialize in califont systems. We only check for leaks and to make sure the califont is operational on day of the inspection. For a comprehensive inspection we suggest a gas fitter/plumber further inspect.
