# Property Inspection Report

**- Habit New Zealand Limited -**

***Sample Report. 1945 Direct Fixed Cladding With Issues***

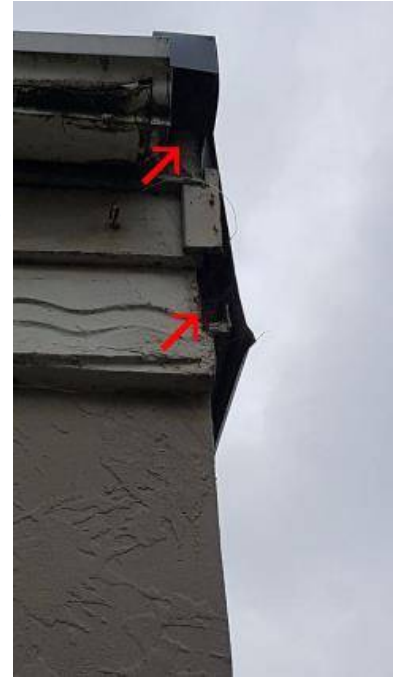
Remedial attention suggested. Poorly installed flashings in this area, This area is a potential moisture ingress risk point. This area may have leaked in the past causing damage to the wall framing which cannot be seen on our visual non invasive inspection. Further investigation is required. . The roofing material requires further investigation by a licensed roofer to give costings.

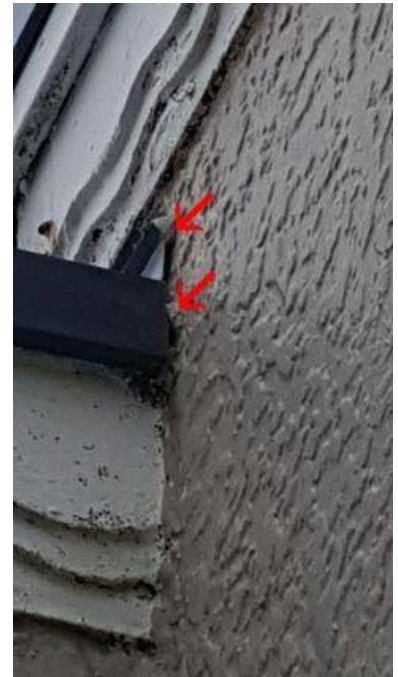
Remedial attention suggested. Poorly installed flashings in this area, This area is a potential moisture ingress risk point. This area may have leaked in the past causing damage to the wall framing which cannot be seen on our visual non invasive inspection. Further investigation is required. . The roofing material requires further investigation by a licensed roofer to give costings.

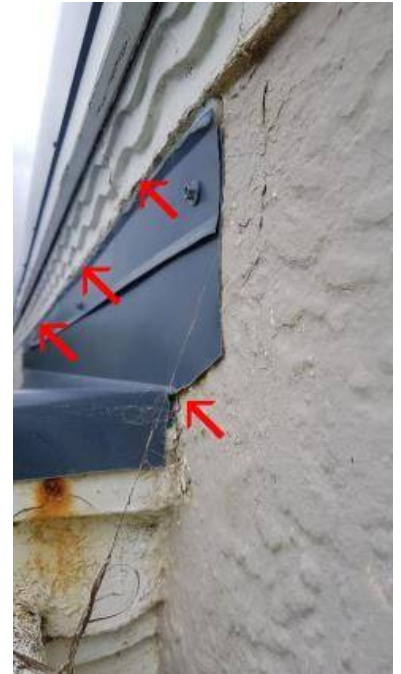
Remedial attention suggested. Poorly installed flashings in this area, This area is a potential moisture ingress risk point. This area may have leaked in the past causing damage to the wall framing which cannot be seen on our visual non invasive inspection. Further investigation is required. . The roofing material requires further investigation by a licensed roofer to give costings.

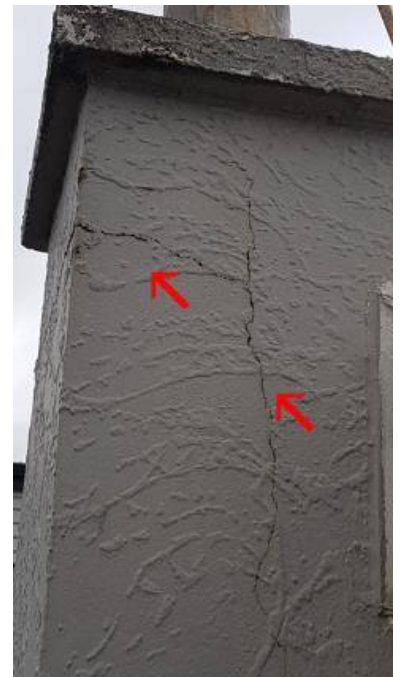
Remedial attention, cracking evident.

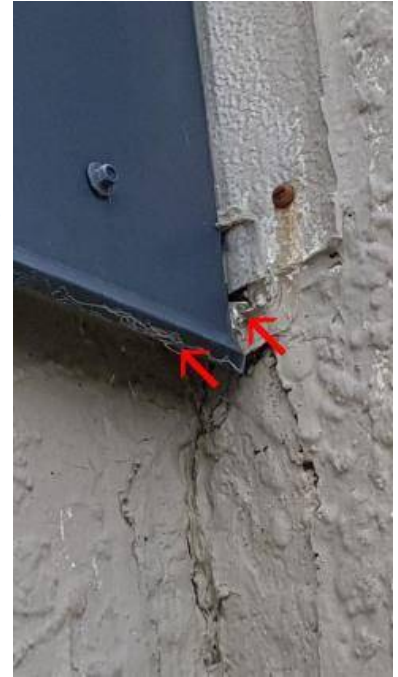
Remedial attention suggested. Poorly installed flashings in this area, This area is a potential moisture ingress risk point. This area may have leaked in the past causing damage to the wall framing which cannot be seen on our visual non invasive inspection. Further investigation is required. . The roofing material requires further investigation by a licensed roofer to give costings.

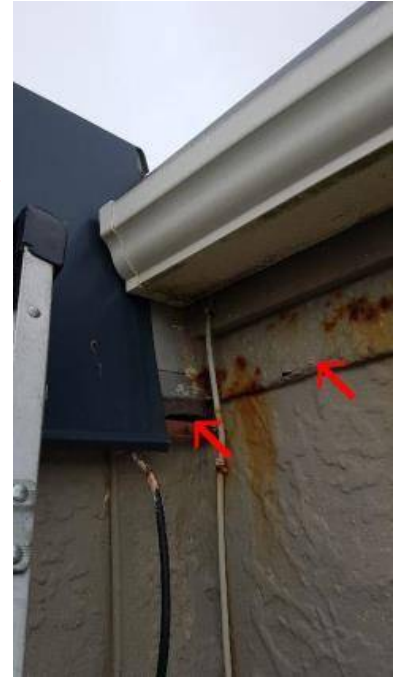
Remedial attention fully rusted out original flashing. Remedial attention suggested. Poorly installed flashings in this area, This area is a potential moisture ingress risk point. This area may have leaked in the past causing damage to the wall framing which cannot be seen on our visual non invasive inspection. Further investigation is required. . The roofing material requires further investigation by a licensed roofer to give costings.

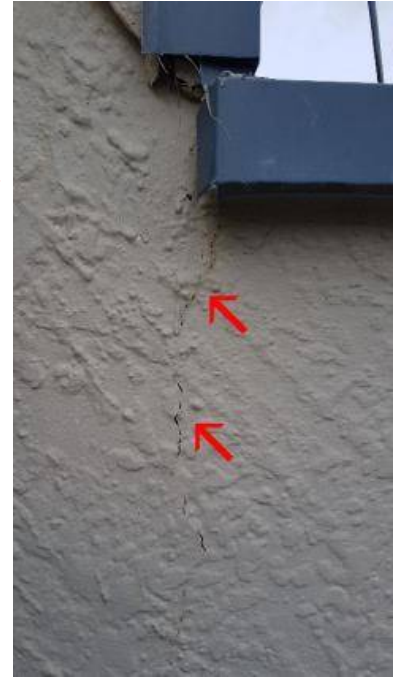
Remedial attention suggested, Damage evident, replacement of damaged area may be the best or easiest option here, This area is a potential moisture ingress risk point. This area may have leaked in the past causing damage to the wall framing which cannot be seen on our visual non invasive inspection. Further investigation is required.

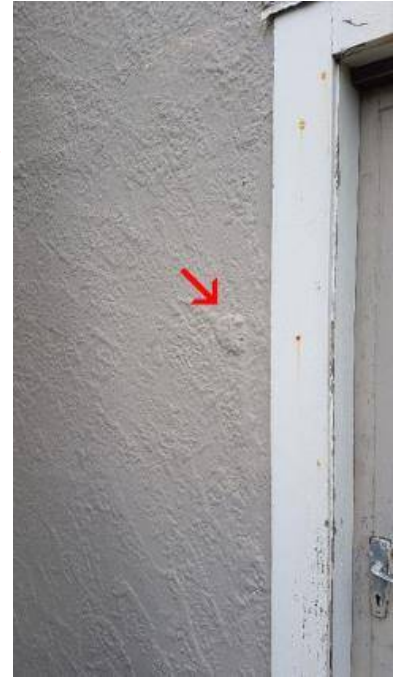
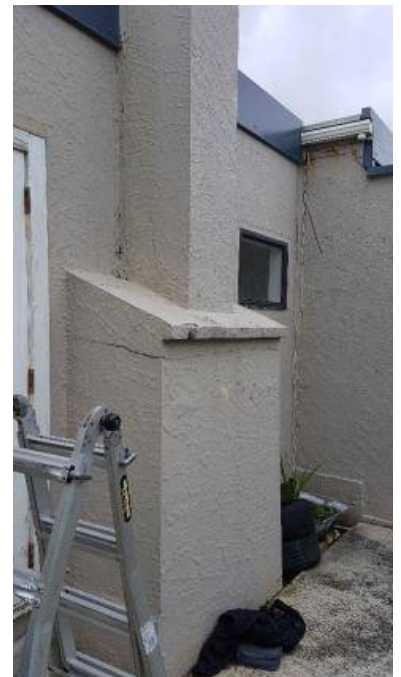
Remedial attention, blown out plaster, this is a sign of moisture ingress. This area is a potential moisture ingress risk point. This area may have leaked in the past causing damage to the wall framing which cannot be seen on our visual non invasive inspection. Further investigation is required.

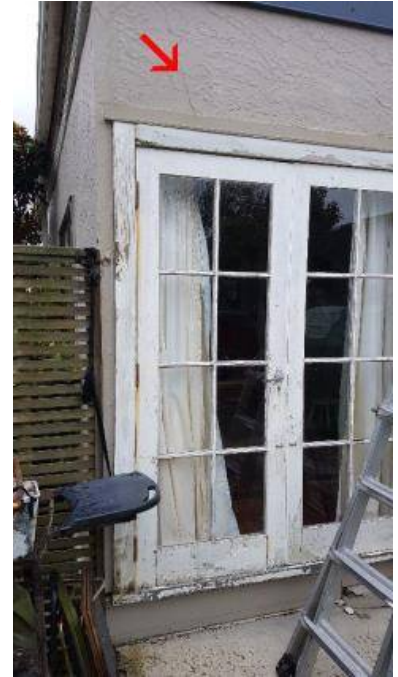
Remedial attention, cracking evident. This area is a potential moisture ingress risk point. This area may have leaked in the past causing damage to the wall framing which cannot be seen on our visual non invasive inspection. Further investigation is required.

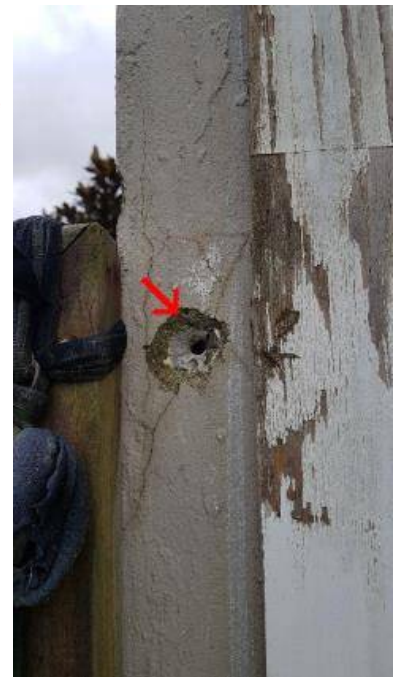
Remedial attention, cracking evident. This area is a potential moisture ingress risk point. This area may have leaked in the past causing damage to the wall framing which cannot be seen on our visual non invasive inspection. Further investigation is required.

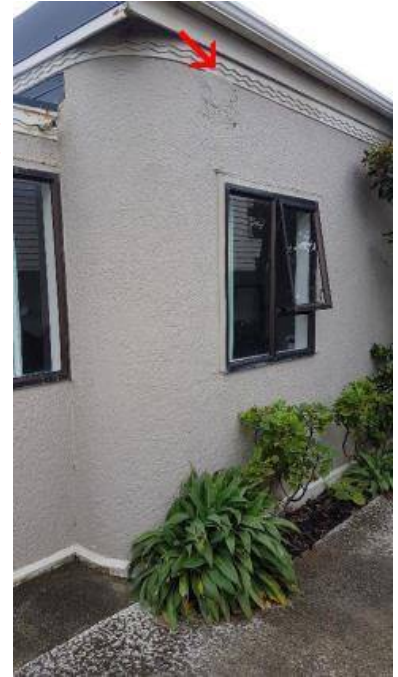
Remedial attention suggested, Damage evident, replacement of damaged area may be the best or easiest option here. This area may have leaked in the past causing damage to the wall framing which cannot be seen on our visual non invasive inspection. Further investigation is required.

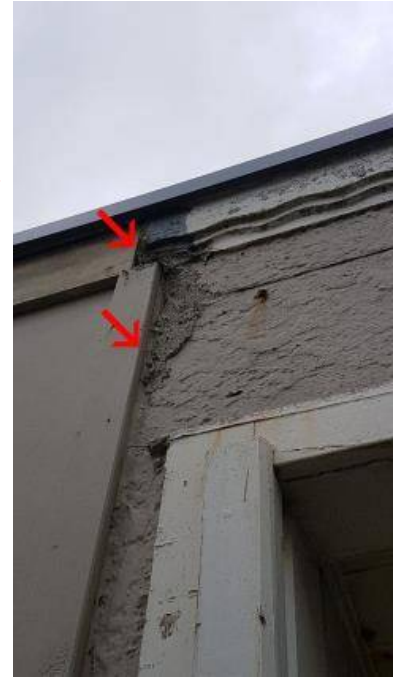
Remedial attention suggested, Damage evident, replacement of damaged area may be the best or easiest option here. This area is a potential moisture ingress risk point. This area may have leaked in the past causing damage to the wall framing which cannot be seen on our visual non invasive inspection. Further investigation is required.

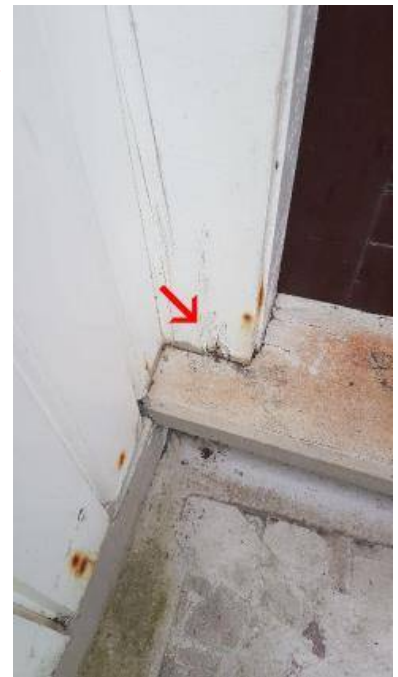
Remedial attention suggested, Damage evident, replacement of damaged area may be the best or easiest option here. Further investigation is required as the condition of the timber is not known, damaged may have been caused within the wall and cavity that cannot be viewed on our non invasive inspection.

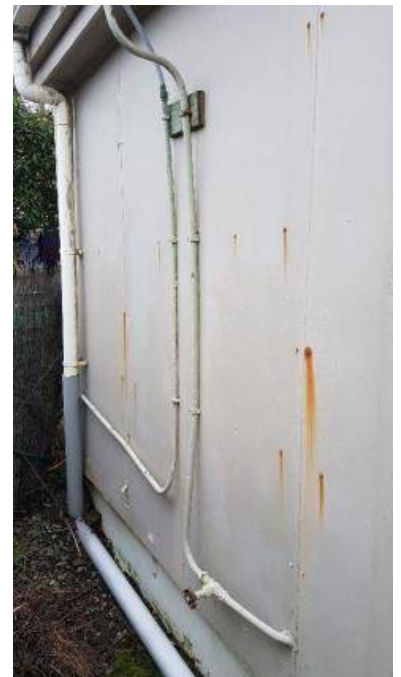
Remedial attention all the sheet fixings are rusted, this is a sign of moisture, further investigation and treatment or replacement is required.

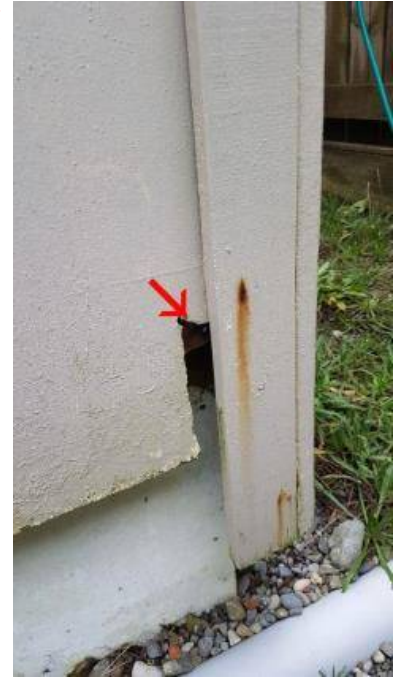
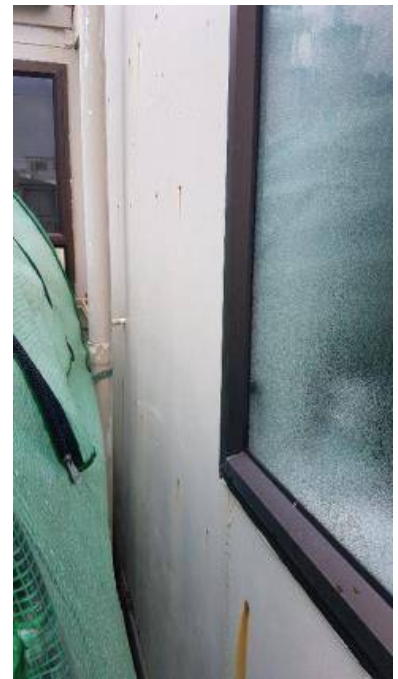
Compressed fiber cement, The cladding may or may not be asbestos, refer to main summary (please read all comments)  
Remedial attention suggested, Damage evident, replacement of damaged area may be the best or easiest option here.

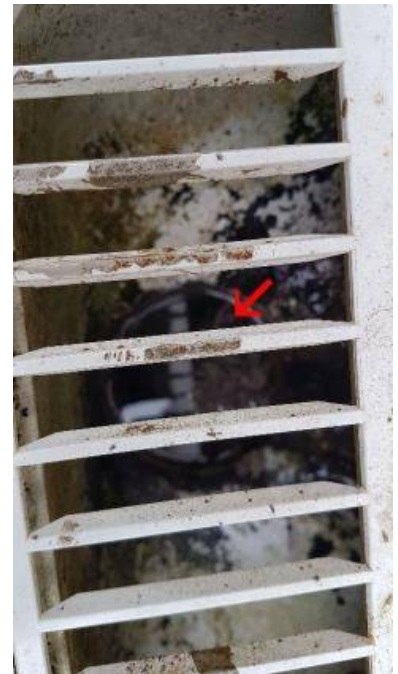
*Gully Trap* P.V.C, Remedial attention required, Further investigation required by a registered plumber, both the gully trap for bathroom and kitchen are blocked  
We recommend all drains are checked with a camera and cleared if need be. On our visual inspection we cannot determine the condition of this pipe work. Blocked drains can occur at any time so it does pay to check, even though there were no signs on inspection.

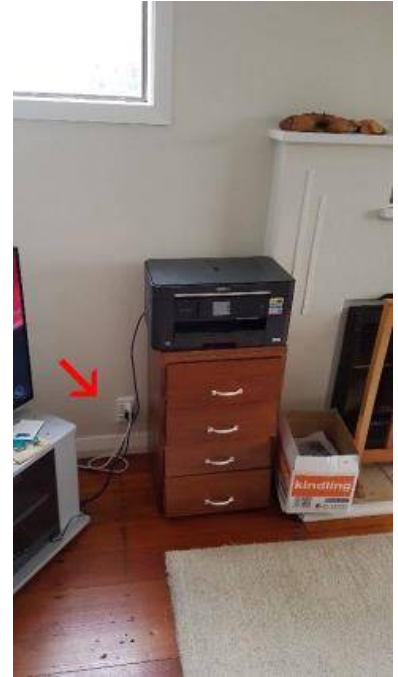
Relative moisture readings of concern were found in this area. Further investigation is required in this area, as this is only a non invasive inspection we cannot determine if there has been any damage caused to the wall framing.

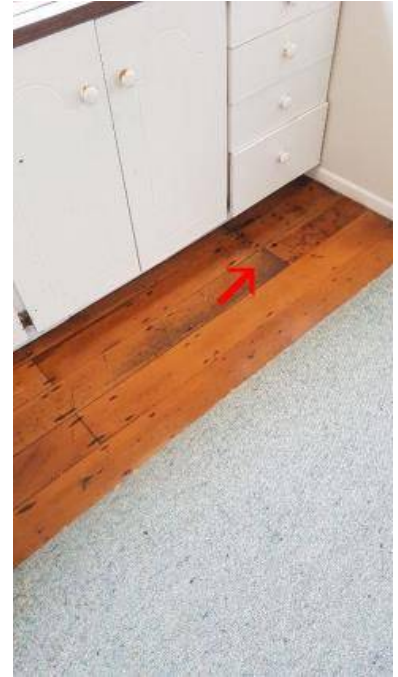
Remedial attention suggested, Damage evident, possible replacement of damaged area required.

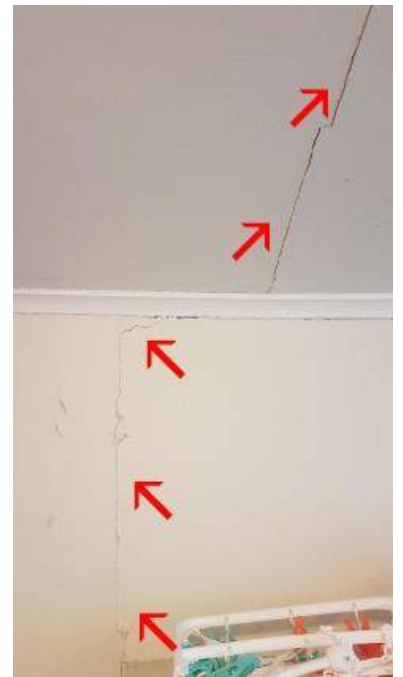
Large cracking to the wall linings in the bathroom. The bathroom floor is also unlevel. There is subsidence evident in this area. A engineer is required to investigate further.

Remedial attention large cracking to wall linings, subsidence evident, further investigation by a structural engineer is required.

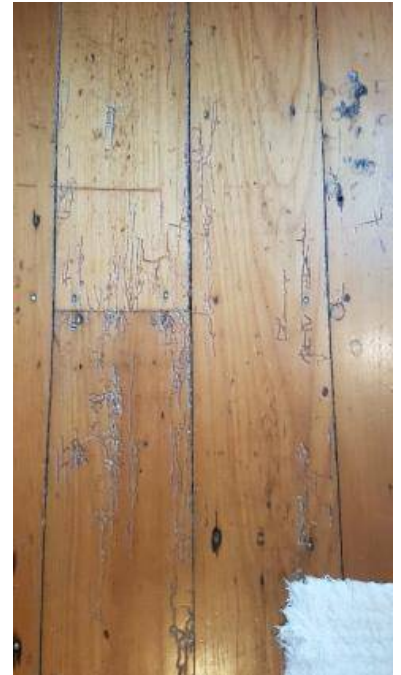
*Floor Covering:* Polished timber, **Historical Borer signs evident. Further investigation required by a pest specialist. We cannot determine the extent of damage caused within the timber on our non invasive inspection.**

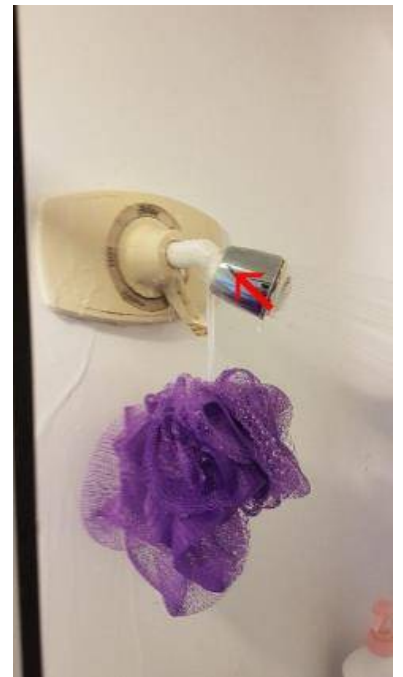
Single mixer, Reasonable pressure. Remedial attention suggested, Leaking water control evident.

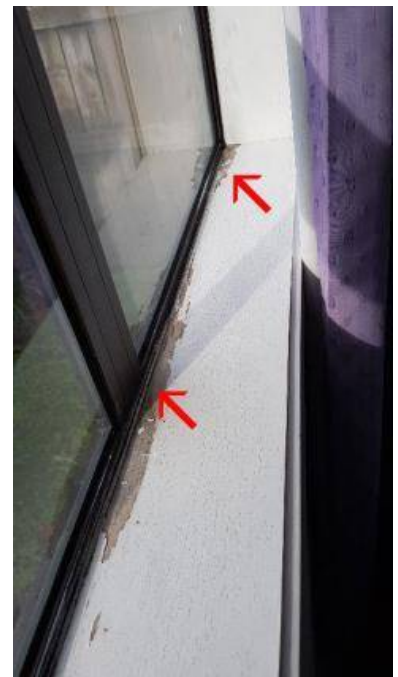
Remedial attention suggested. Damage evident, possible replacement of damaged area suggested. Be aware the window sills in this dwelling are custom wood, this product swells when wet, such as condensation off the aluminium joinery, be sure to keep the sills well sealed and painted.

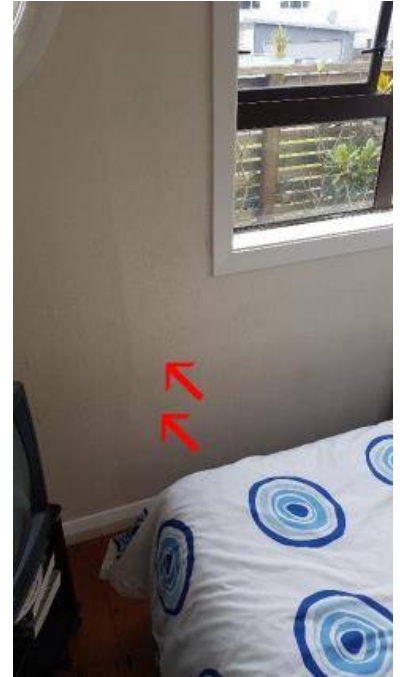
Mould evident to ceilings and walls in this room, there is a moisture and or ventilation issue here.

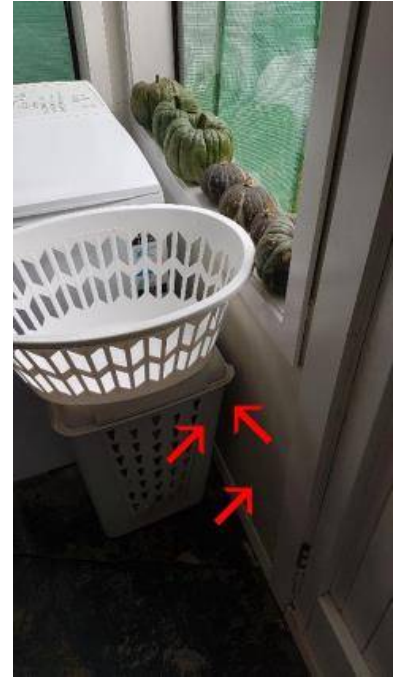
Relative moisture readings of concern were found in this area. Further investigation is required in this area, as this is only a non invasive inspection we cannot determine if there has been any damage caused to the wall framing.
