Property Inspection Report

- Habit New Zealand Limited -

***Sample Report
1960's Weatherboard***

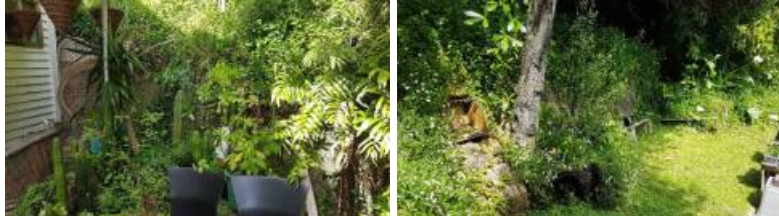
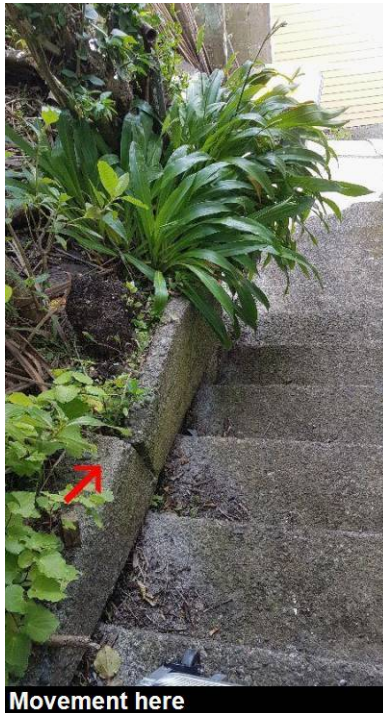
There area areas of movement. Shown below. Suggested replacement of the worst affected areas.

<i>Exterior Stairs:</i>	Subsidence evident, the steps have dropped away from the house, the inspector recommends remove, better drainage installed and the new steps.
-------------------------	---

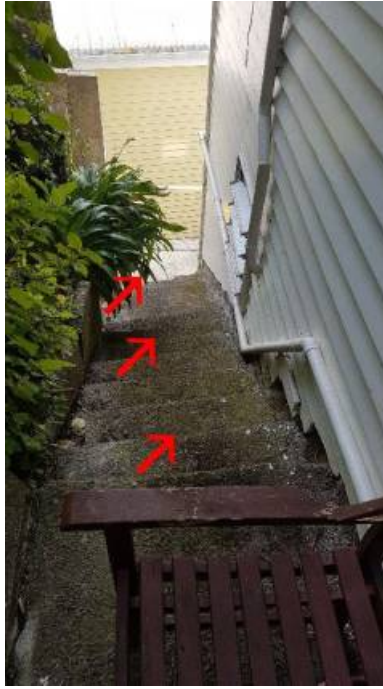
Paths:

Subsidence evident, paths have dropped over time. The inspector suggests better drainage is installed as there is a lot of water run off from the bank above the property.

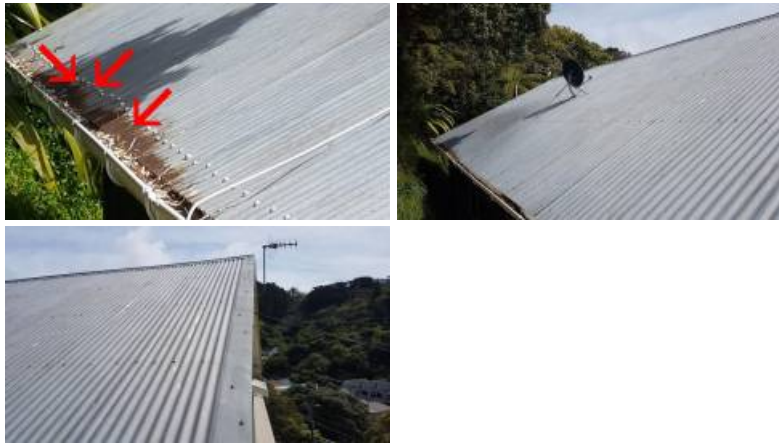
Corrugated iron painted, Material in, Reasonable Condition, Remedial attention suggested to the rusted area, The roofing material requires further investigation by a licensed roofer to give you the right advice on the degree or replacement, upgrades and costings.

The inspector suggests all lead head nails are replaced as they rust from the inside out and will deteriorate the roofing iron. Without removing nails ourselves we cannot confirm if damage to the iron has already occurred. In some cases iron may need to be replaced and this can only be identified by the roofer when nails are removed.

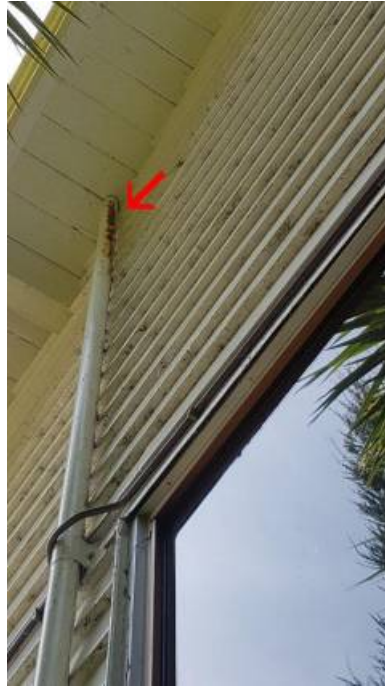
Outlet Pipes:

Galvanised iron. Remedial attention, rust and corrosion evident, suggested replacement.

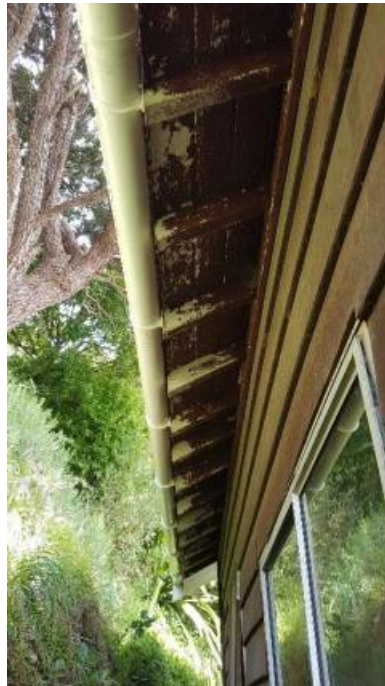
Eaves: Painted timber, Remedial attention suggested, Cosmetic upgrade required.

Back Porch: Remedial attention required, Replacement of the damaged area.

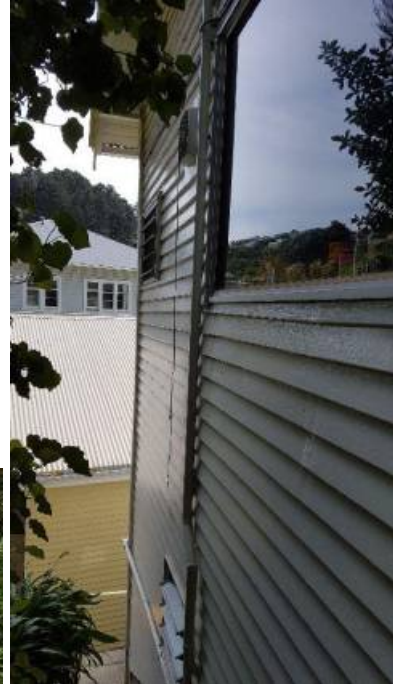
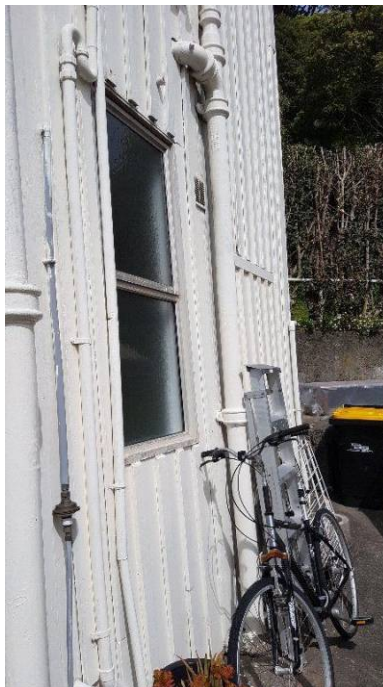
Painted weatherboard, board and batten, Material in, Reasonable Condition.

Remedial attention suggested to some areas which require upgrades or replacement. A licensed building practitioner can carry out this work.

Attention required to this area

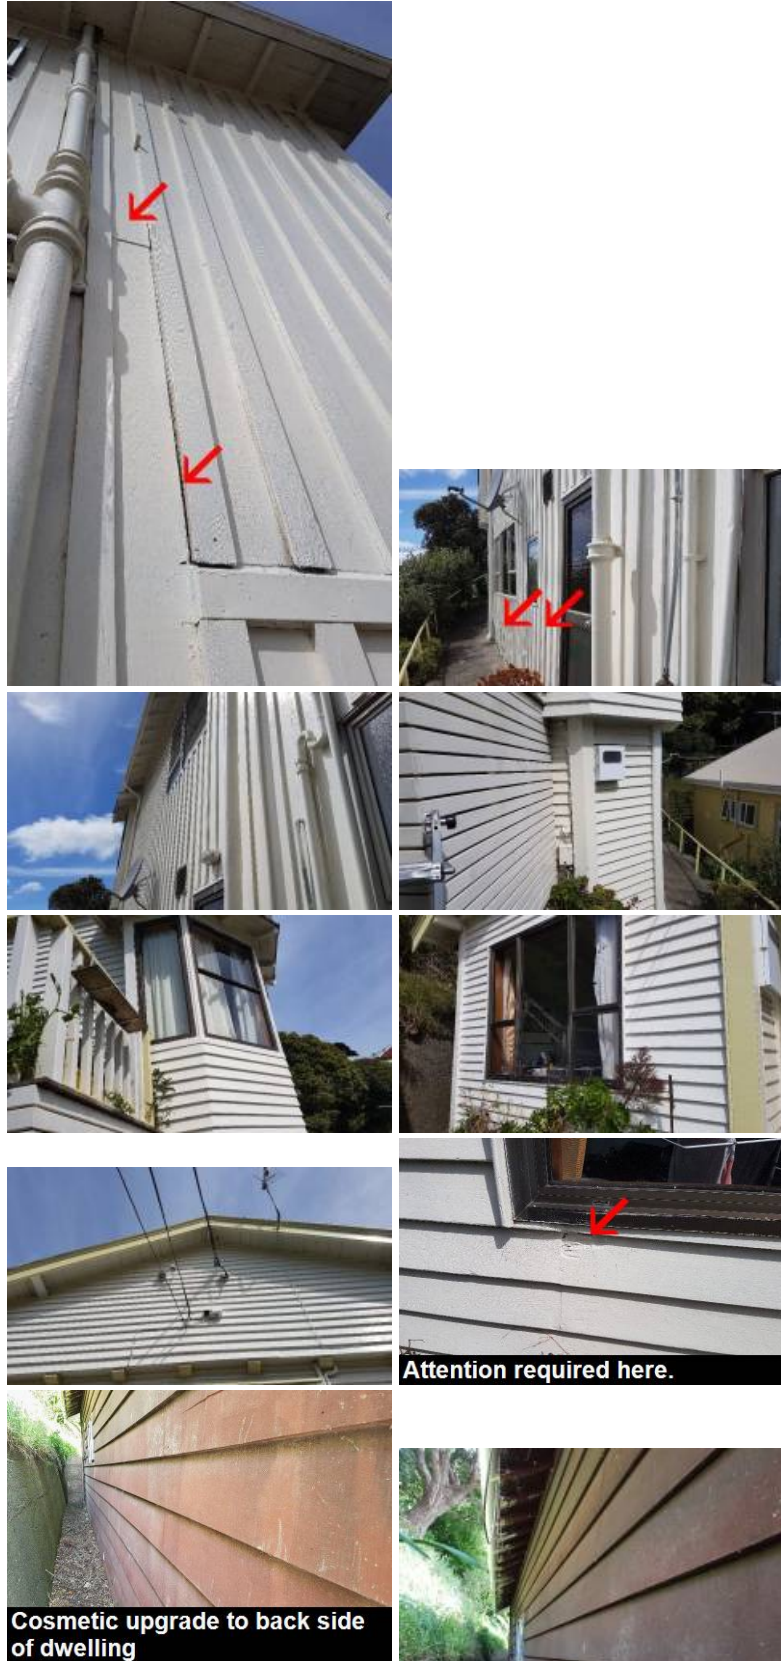
Cladding Penetrations:

Sealing required around the penetrations through the cladding. This area is a potential moisture ingress point. moisture may have already entered this area but on our visual inspection this cannot be seen. Further investigation required.

Sealing required around these penetrations through the cladding. This area is a potential moisture ingress point. moisture may have already entered this area but on our visual inspection this cannot be seen. Further investigation required.

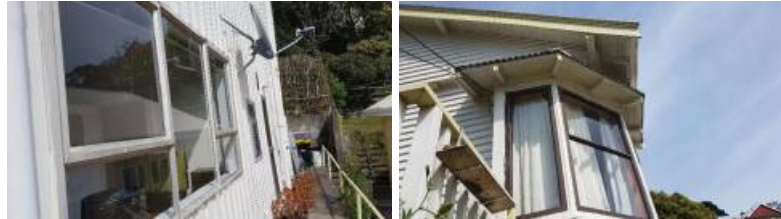
External Joinery

Deteriorated rubber window seals to the aluminium joinery. All affected rubbers require replacement. These areas may have leaked in the past causing damage to the wall framing which cannot be seen on our visual non invasive inspection. Further investigation is required.

Aluminum, Material in, Reasonable Condition. Remedial attention suggested, Deteriorated windows seals evident, recommended replacement.

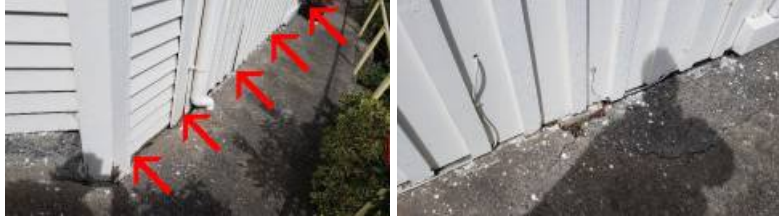
Foundation:

Foundation Area comments: Remedial action to be carried out, Further investigation required as the house has dropped considerably but piles could not be viewed as the house has been built very close to ground level.

Remedial attention, further investigation to all piles and subfloor framing.

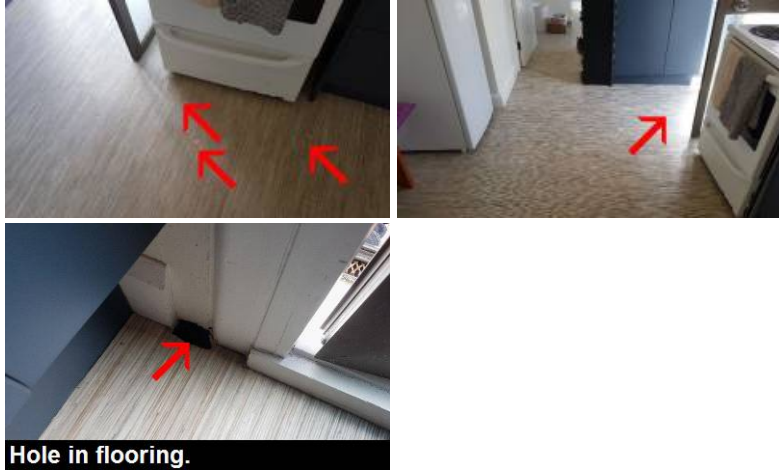
Vinyl fitted, Reasonable Condition, Remedial attention suggested, Damage evident, possible replacement of damaged area required.

Piles have settled causing floors to be out level in areas of this room. Further investigation is required.

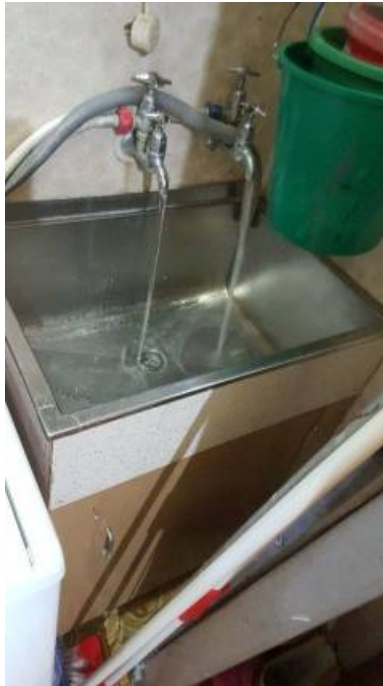
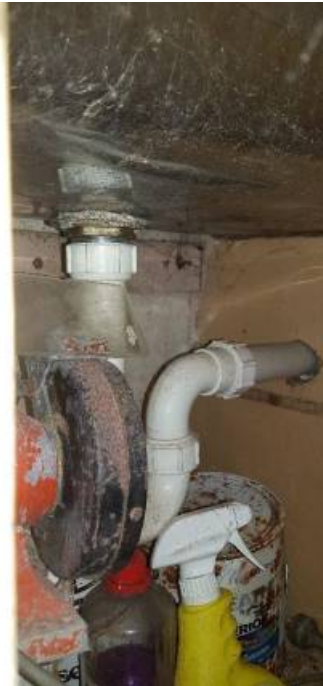
Areas of moisture

Relative moisture readings of concern were found in this area. Further investigation is required in this area, as this is only a non invasive inspection we cannot determine if there has been any damage caused to the wall framing.

The cause of these moisture readings is unknown.

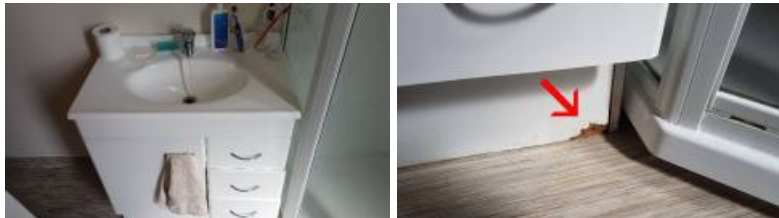
Vanity Unit General: 1 unit, Draining well without blockages,

High relative moisture readings and a damage carcass to the vanity was viewed in the downstairs bathroom. The shower is leaking. The shower required attention by a shower specialist. Further investigation is required as the condition of the timber wall framing is not known, damaged may have been caused within the wall cavity that cannot be viewed on our non invasive inspection.

Requires remedial attention, water damaged carcass to be replaced.

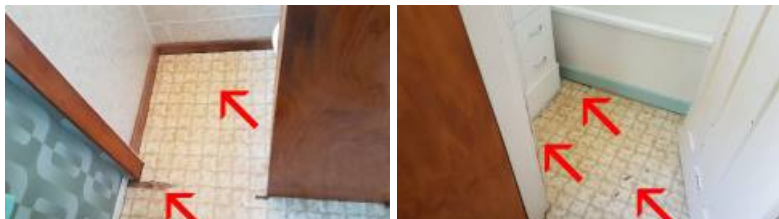
Floor Covering:

Vinyl fitted, Piles have settled causing floors to be out level in areas of this room. Further investigation is required. Remedial attention suggested, Damage evident, possible replacement of damaged area required.

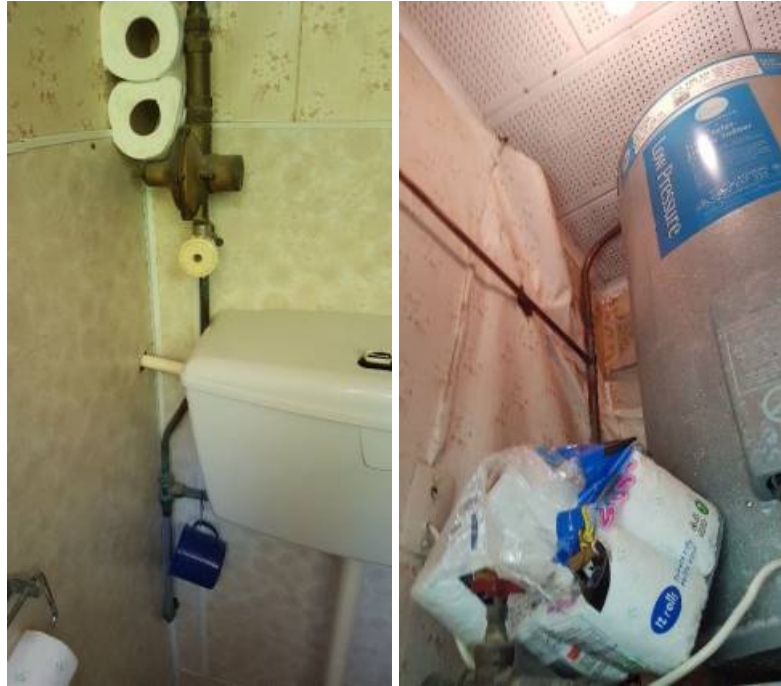
Seismic Strap:

Seismic strap not fitted, [Requires a seismic strap to be fitted.](#)
