# Property Inspection Report

**- Habit Whakatane -**

***Sample Report Monolithic***

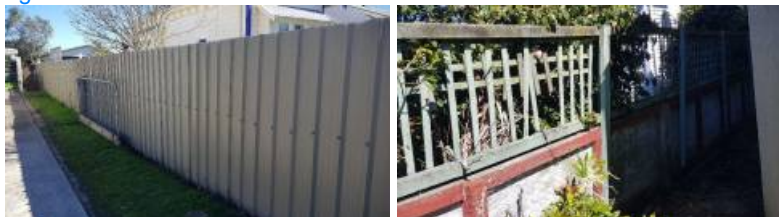
Timber, Remedial attention suggested, Replacement of damaged or excessively aged material.

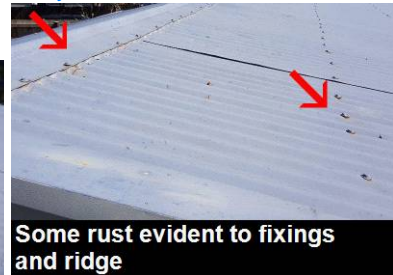
Corrugated iron unpainted Secured well in place, Material in, Reasonable Condition but some rusting evident to ridge area.

I suggest all lead head nails are replaced as they rust from the inside out and will deteriorate the roofing iron. Without removing nails ourselves we cannot confirm if damage to the iron has already occurred. In some cases iron may need to be replaced and this can only be identified by the roofer when nails are removed.

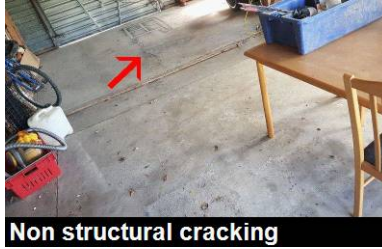
**Non structural cracking**

Concrete floor slab (unpainted), cracking is evident, this is due to natural movement and curing, not a structural issue.

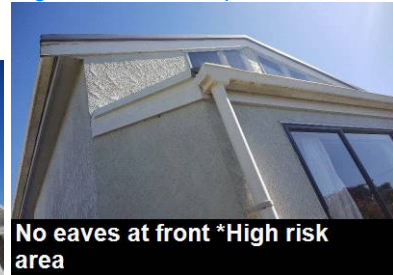
*Eaves:* Paint compressed fibre cement, Secured well, Material in, Reasonable Condition.  
**Remedial attention suggested, Re-fixing of eave area required.**

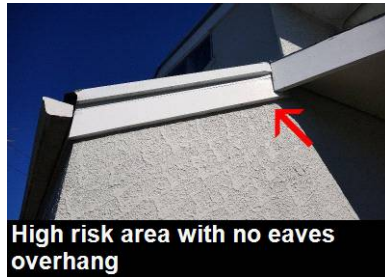
**High risk area with no eaves  
overhang**

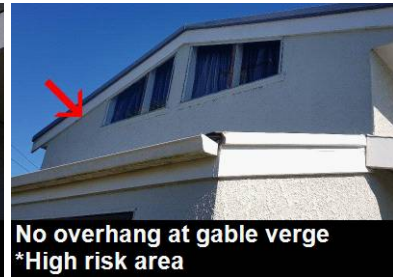
**No overhang at gable verge  
\*High risk area**

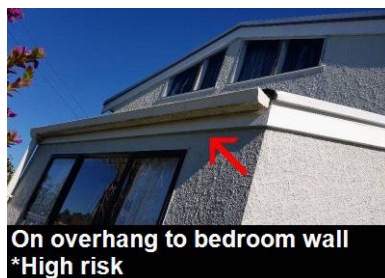
**On overhang to bedroom wall  
\*High risk**

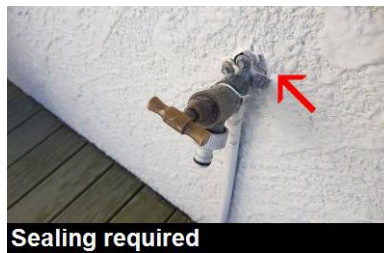
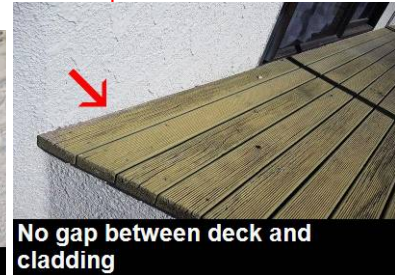
Sealing required around these penetrations through the cladding. No physical evidence of moisture at time of inspection but this is a risk area that requires sealing and monitoring. This area is a potential moisture ingress point, moisture may have already entered this area but on our visual inspection this cannot be seen.

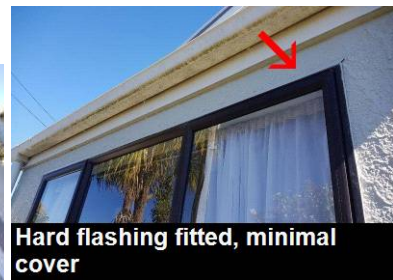
**Remedial attention required.** This flashing does not extend past the window head enough to meet current requirements, a licensed building practitioner can carry out this remedial task. These areas are potential moisture risk points. These areas may have leaked in the past causing damage to the wall framing which cannot be viewed on our non invasive inspection. Further investigation is required.

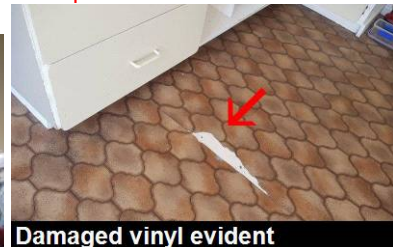
Vinyl fitted, Reasonable Condition, Remedial attention suggested, Damage evident, possible replacement of damaged area required.

**Damaged vinyl evident**
