Property Inspection Report

- Habit Whakatane -

Sample Report Single Storey

Prepared for: HABiT

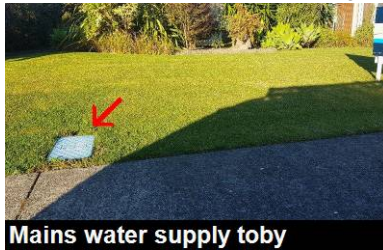
Mains water supply toby

Found at the front of the dwelling.

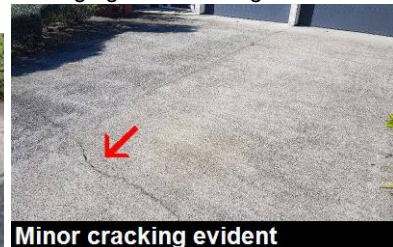
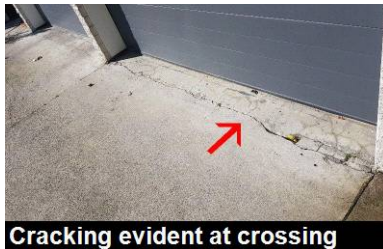
Driveway:

Concrete, Reasonable condition, Natural aging and cracking evident.

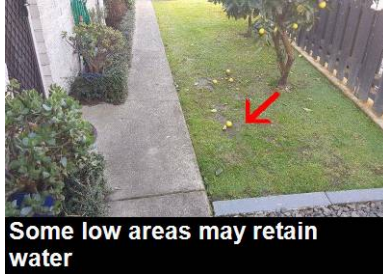
Water Pooling:

Lower areas allow dampness and possible minor water pooling, noted.

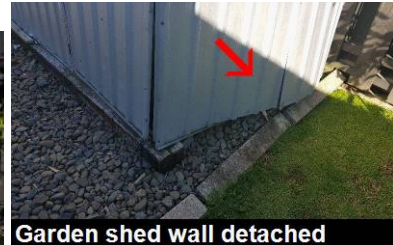
Ancillary Buildings and service areas: Garden shed, reasonable condition but with some wall damage evident.

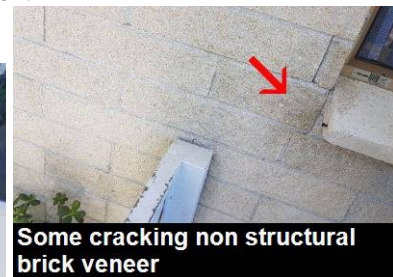
External Wall Cladding:

Brick veneer, Material in, Good Condition for age in general but there is some evidence of settlement and movement.

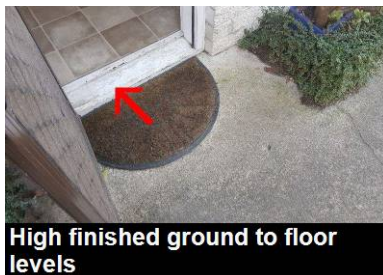
Ground Clearances

Insufficient ground clearance here, the clearance from the top of the finished ground height outside to the finished floor level inside, and to the bottom of the cladding is insufficient. This type of construction met the standards and regulations at the time of construction but is known to fail. This area may have leaked in the past causing damage to the wall framing which cannot be viewed on our non invasive inspection. I suggest these ground heights are dropped where possible and additional drainage added where possible as a precaution.

*Vendor informs of previous historical flooding event from overflowing swimming pool next door that flowed into Laundry and Garage area near back door - Extra soak holes have been added at side area of garage.

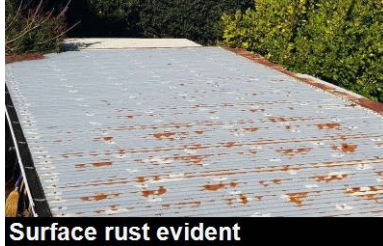
Corrugated iron painted, in aged and deteriorating condition but appeared water tight on day of inspection, although it was not raining. Surface rust evident and rust to laps, no internal evidence of water damage to office area, rear shed was locked and inaccessible at time of inspection.

I suggest all lead head nails are replaced as they rust from the inside out and will deteriorate the roofing iron. Without removing nails ourselves we cannot confirm if damage to the iron has already occurred. In some cases iron may need to be replaced and this can only be identified by the roofer when nails are removed.

Suggest the roofing material requires further investigation by a licensed roofer to give you the right advice on the degree or replacement, upgrades and costings.

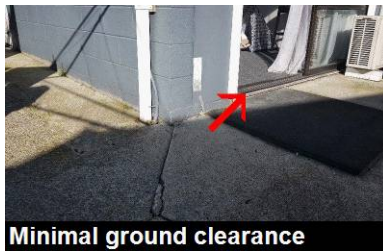
Ground Clearances

Minimal ground clearance here, the clearance from the top of the finished ground height outside to the finished floor level inside. This type of construction met the standards and regulations at the time of construction.

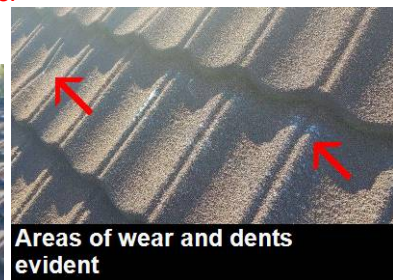
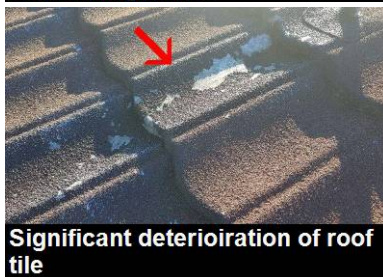
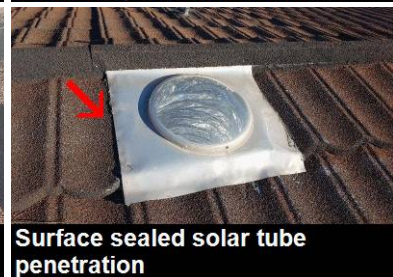
Decromastic tiles in aged and deteriorating condition, dry on day of inspection with no internal evidence of leaking. Evidence of some retrospective repairs and re-fixing to assist with weather tightness of older tiles.

Dent damaged tiles

Significant wear to tiles

Stone chip coating deteriorating

Worn tiles

Rusting to valley tiles

Some surface rust to tiles

Replacement suggested of damaged, dented tiles at water will pool and these tiles will deteriorate quicker than the rest of the roof as a result of this.

Remedial attention suggested - Recommend the roofing material requires further investigation by a licensed roofer to give you the right advice on the degree of replacement, upgrades and costings.

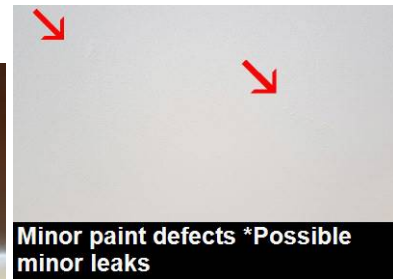
[Remedial attention suggested](#), [Damage evident, possibly due to minor roof leaks over time to older roof tile, repair of damaged area suggested](#). Ceiling linings.

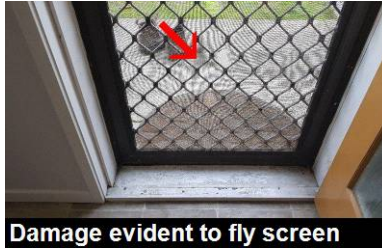
Remedial attention suggested, Damage evident, Possible repair of damaged area suggested.

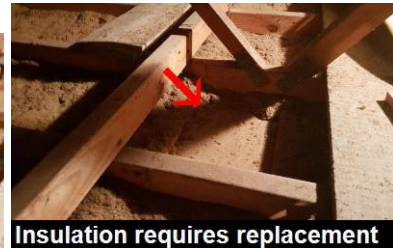
Insulfluff insulation, Remedial attention required on the insulation in this area. Insulation either removed or deteriorated to the degree that replacement or addition of insulation is required.
