Property Inspection Report

- Habit Whakatane -

Sample Report Two Storey

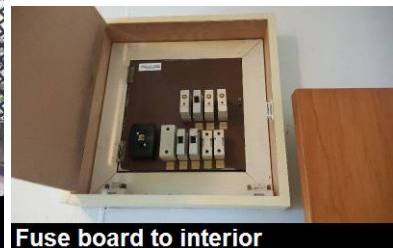
Meter board to exterior, cracks evident

Some modern fuses are installed here the rest are older style fuses. Due to the age and condition of the fuses we recommend a registered electrician further investigate as we do not conduct a full electrical inspection. If there are any fault this will be noted.

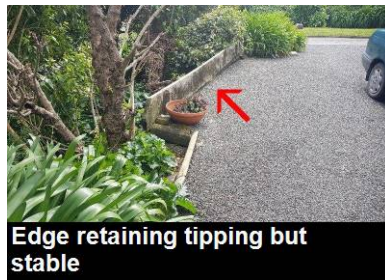
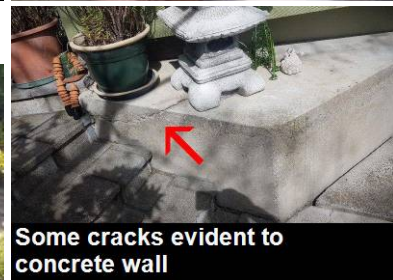
Retaining Walls:

Timber, Reasonably secured, ageing, and minor deterioration evident. Not of a structural concern.

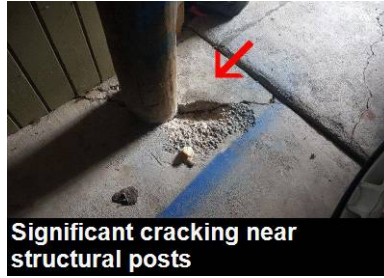
Garage Image 1:

Flooring Concrete floor slab (unpainted), Reasonable Condition, cracking is evident.

Remedial attention suggested, Large cracking evident due to seismic movement. Recommend possible further investigation by registered engineer.

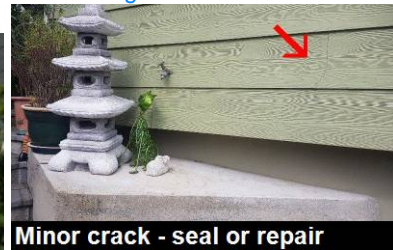
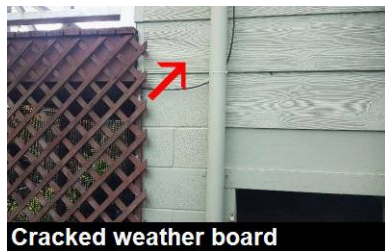
Hardie Plank. direct fixed cladding, no cavity system installed, Material in, Reasonable Condition.

Remedial attention suggested, Remedial sealing of hairline fractures.

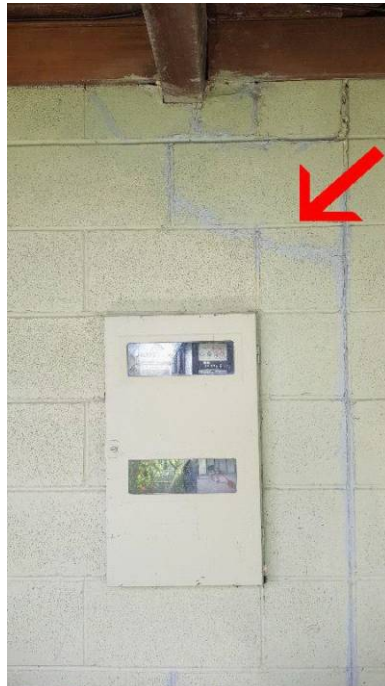
Cracks in foundation. Remedial attention suggested - *Recommend further investigation by registered engineer.

Cracking moving towards expansion area

Remedial attention suggested, Due to significant evidence of seismic movement and crack damage an engineers opinion is highly recommended on this matter as a precaution.

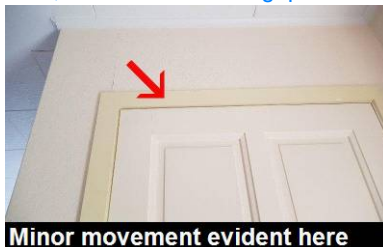
Hinged door, Sliding door, Functioning Reasonably. [House has settled through here, this is seen in the gap between the door frame and door panel.](#)

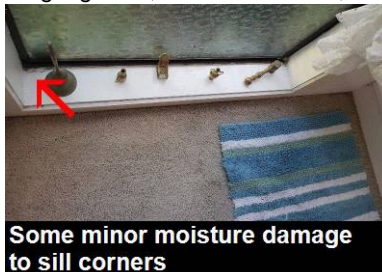
Window Reveals & Sills

Base materials are in, Reasonable condition. Painted. Remedial attention suggested. Damage evident, possible repair of damaged area suggested.

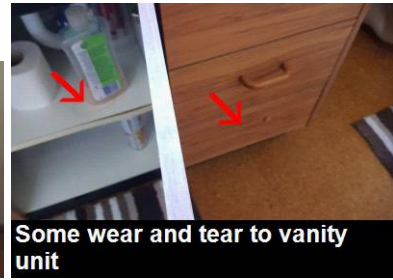
Some wear and tear to vanity unit

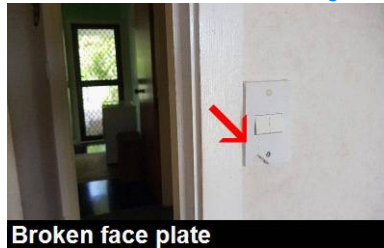
Power Points & Sockets: Double Switch Socket. [Damage face plate, suggested replacement.](#)

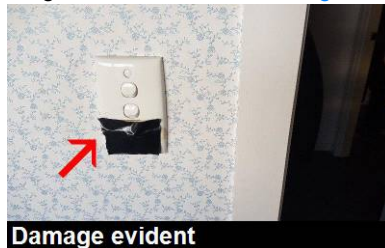
Power Points & Sockets: Single Switch Socket. [Damage face plate, suggested replacement.](#)
