# Property Inspection Report

**- Habit New Zealand Limited -**

***One Bedroom Apartment***

<i>Date:</i>	This dwelling was inspected on 14/06/2017. This report refers to findings on that day only.
<i>Time of Appointment:</i>	11:30 a.m.
<i>Inspection For:</i>	This report is for the sole benefit of: Sample Report.
<i>Inspector on this property:</i>	Habit New Zealand Limited.
<i>People on Site:</i>	Sample Report.
<i>Weather:</i>	Fine and sunny.
<i>General Description:</i>	This is a multi story building, the purpose of the inspection was to inspect room 807 only.

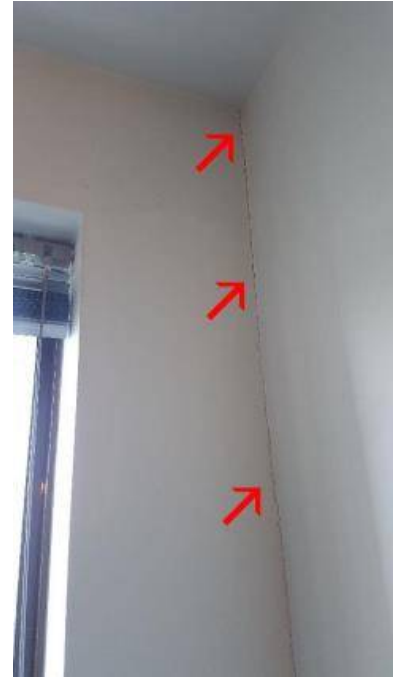
*Internal ceiling and wall linings:* Base linings intact, Reasonable Condition. Slight cracking where a internal partition light weight wall meets the exterior solid concrete wall, this is not a structural concern.

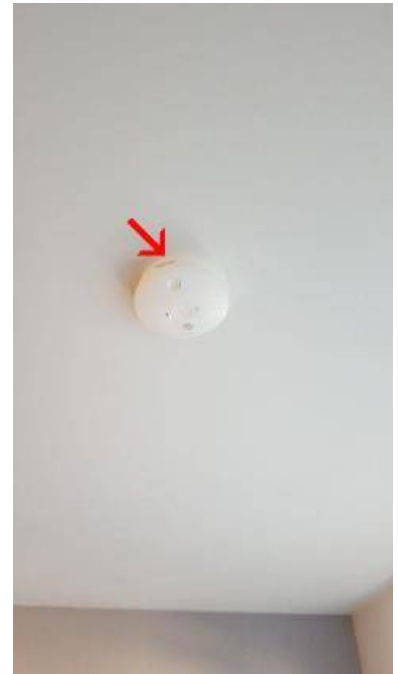
Sprinkler system installed in this room.

Battery smoke detector fitted in this room. Smoke detectors must be installed a minimum of 400mm from the internal corner of the wall and ceiling to meet current regulations and to operate as designed.

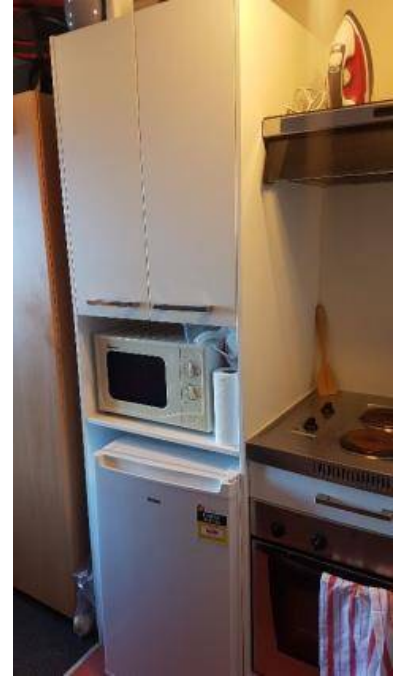
Reasonable condition, functions adequately.

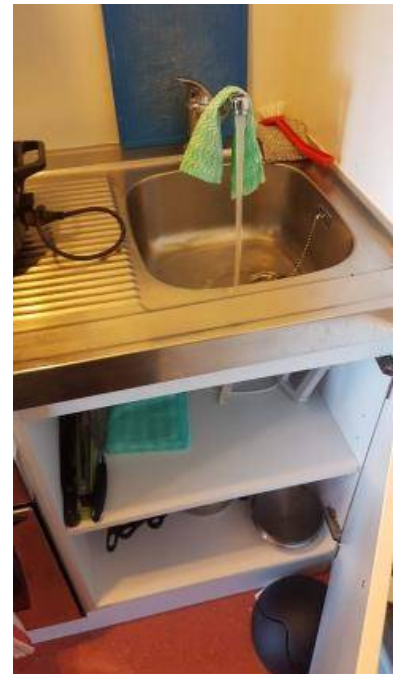
Single, Stainless steel, Draining well without blockages.

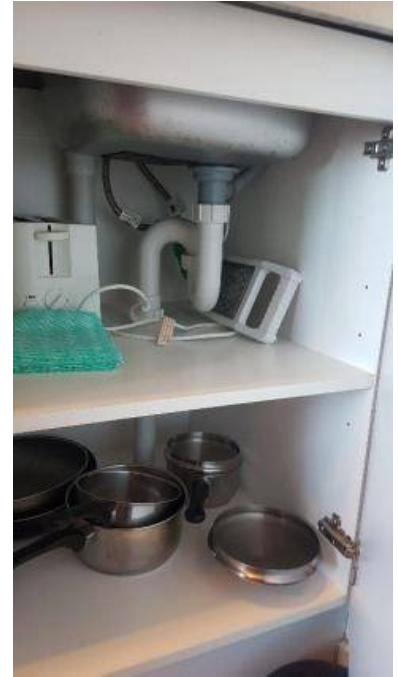
Flexi hose installed here. No plumbing running in the wall cavity was viewed, the plumbing product is unknown unless viewed in the subfloor or ceiling space and this will be noted on in their respective areas of the report. The waste pipe in this area is modern PVC.

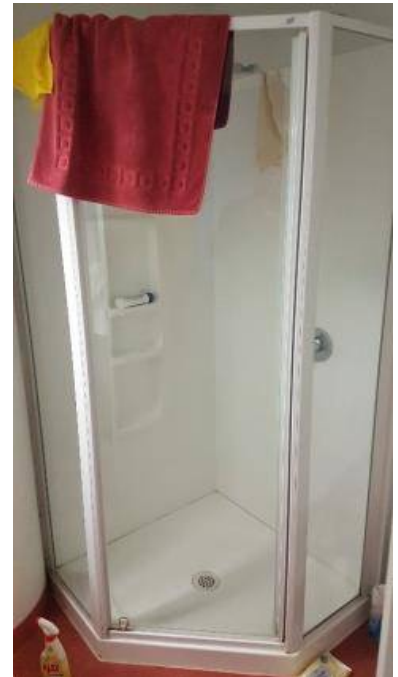
*Shower:* PVC linings, Glass surround, Reasonable Condition.

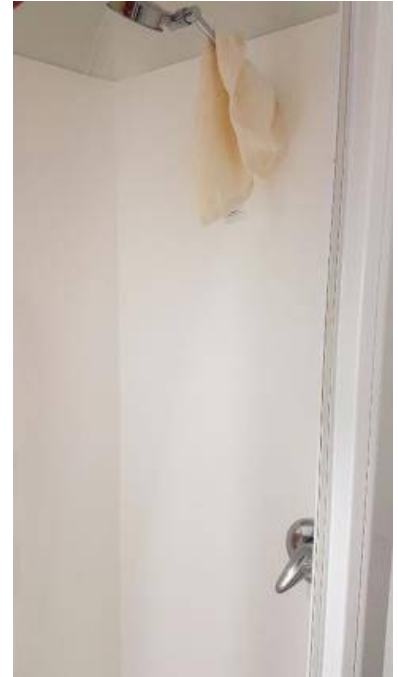
Single mixer, Reasonable pressure.

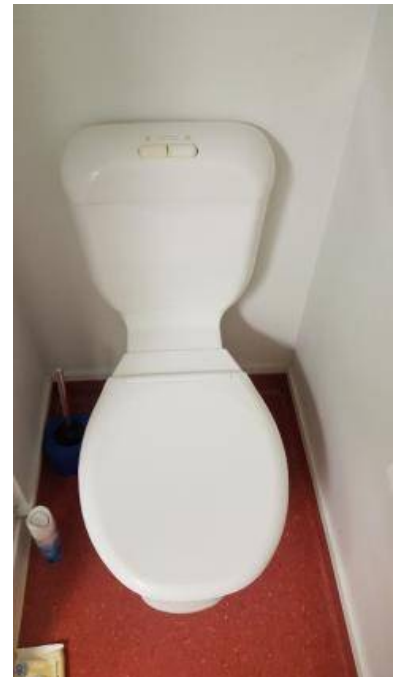
Double flush plastic cistern, Reasonable Condition.

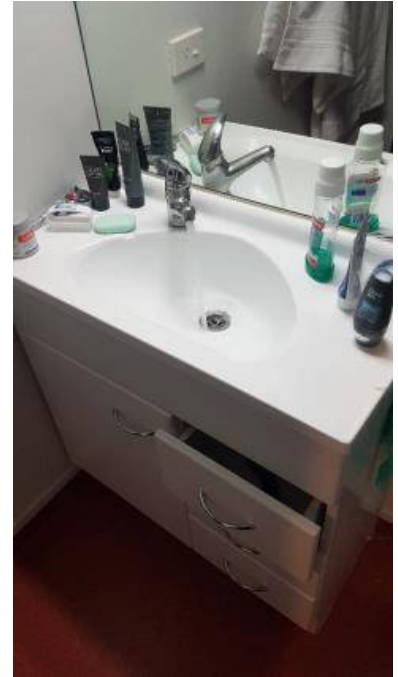
1 unit, Draining well without blockages, Reasonable Condition, minor attention needed.

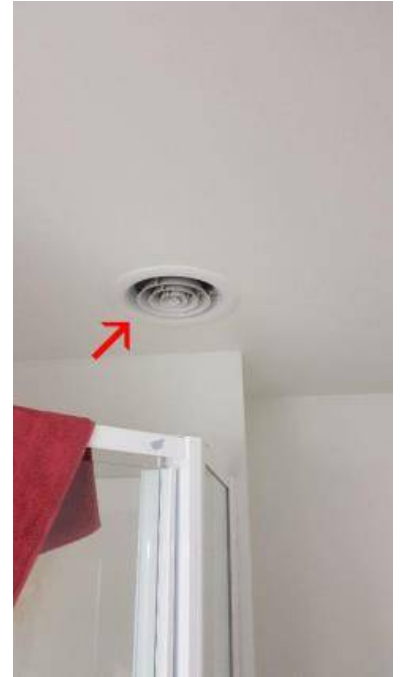
*Extraction Unit:* Manual extraction.

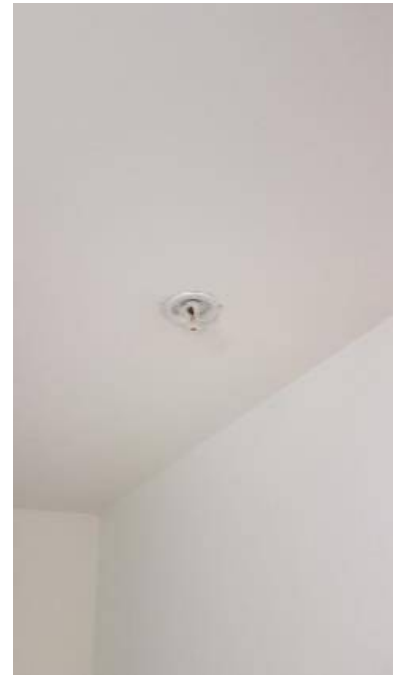
*Smoke Alarms:* Sprinkler system installed in this room.
