Property Inspection Report

- Habit New Zealand Limited -

***Sample Report
1986 Weatherboard***

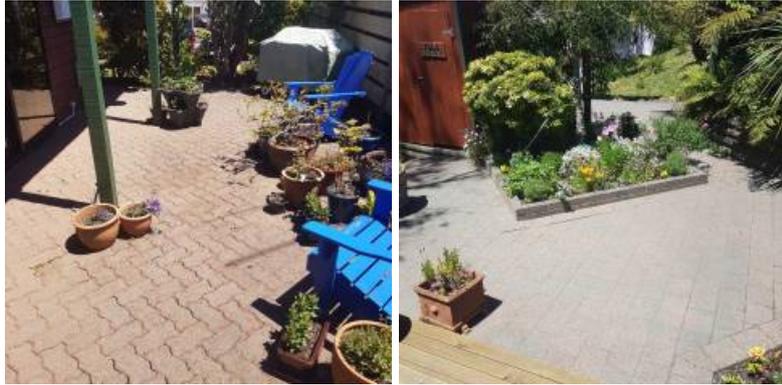
Patio area:

Paving, Reasonable condition out the front. Paving, Good condition out the back.

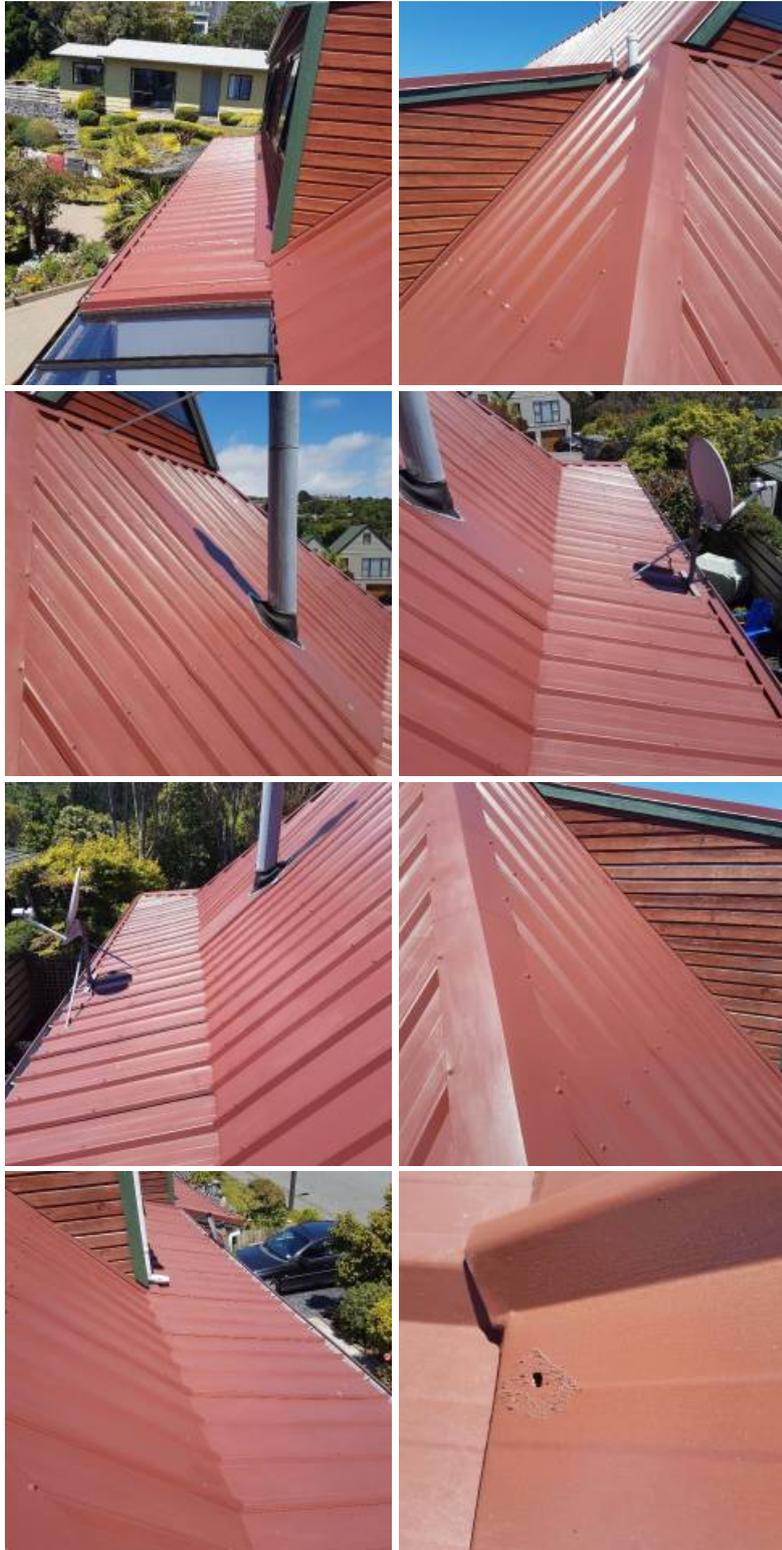
Side roof cladding:

Painted long run iron. Some sheets with just evident, this can also be viewed from inside the roof space. The roof is nearing the end of its life expectancy and will require replacement in the near future. A licensed roofer is required to give you more information of time frames and costings.

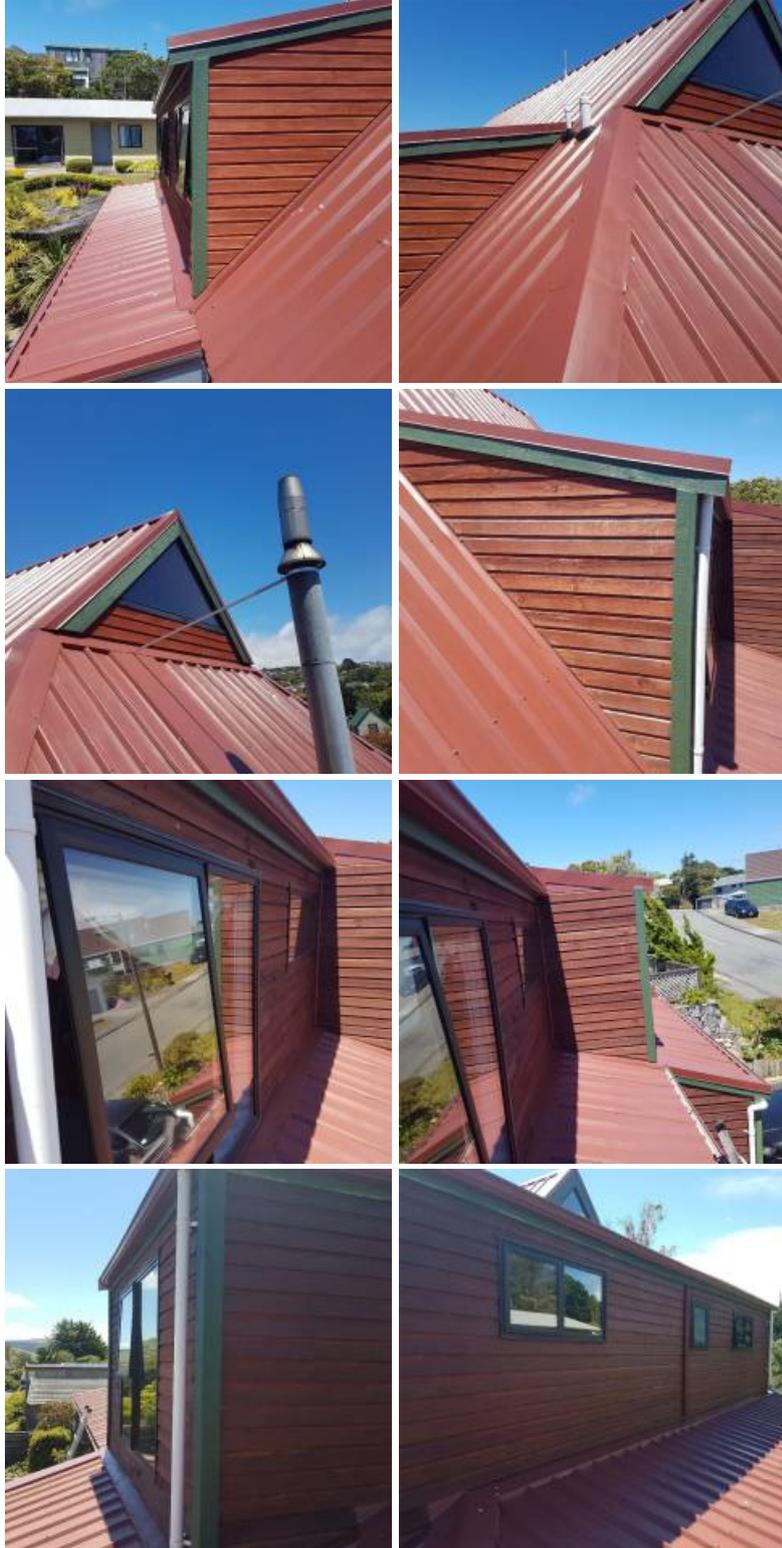
Weatherboards, Material in, Good Condition.

Remedial attention suggested, Timber chucks are required to be installed down the sides of all boxed corners and facings to prevent any moisture ingress. These areas may have leaked in the past causing damage which cannot be viewed on our non invasive inspection. Further investigation required.

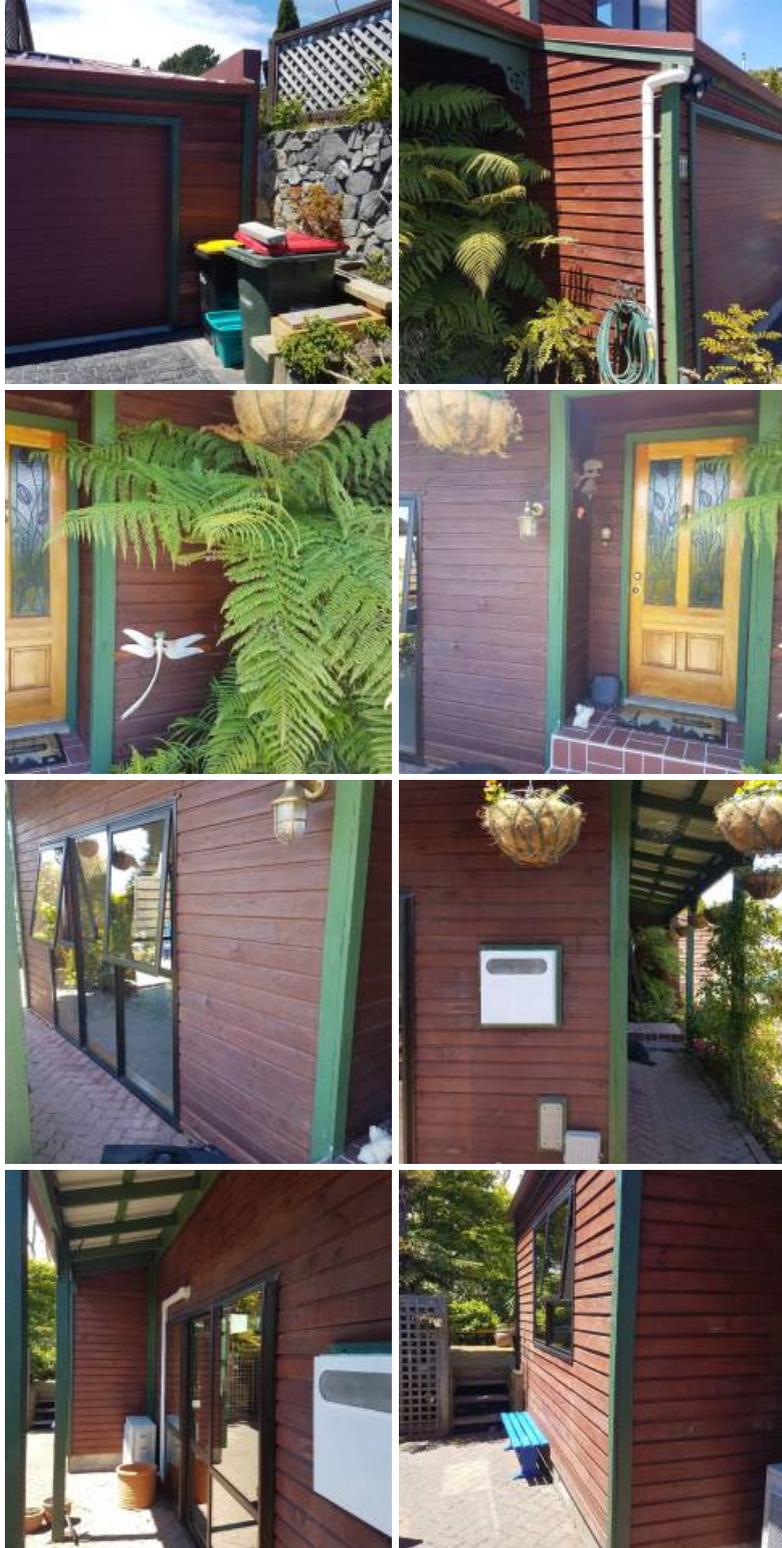
External Wall Cladding:

weatherboard, Material in, Reasonable Condition, Excellent condition to areas that

have been replaced due to cupping.

Remedial attention suggested, Timber chucks are required to be installed down the sides of all boxed corners and facings to prevent any moisture ingress. These areas may have leaked in the past causing damage which cannot be viewed on our non invasive inspection. Further investigation required.

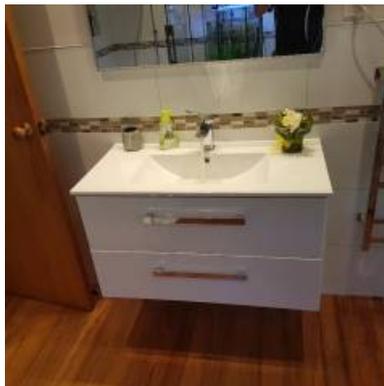
1 unit, Draining well without blockages, Excellent condition, well secured to wall and sealed along the wall junction if needed. Draining well without leaks or blockages.

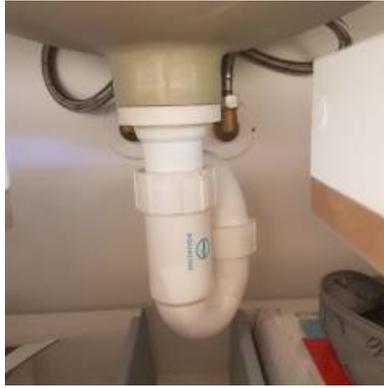
Flexi hose installed here. No plumbing running in the wall cavity was viewed, the plumbing product is unknown unless viewed in the subfloor or ceiling space and this will be noted on in their respective areas of the report.
The waste pipe in this area is modern PVC.

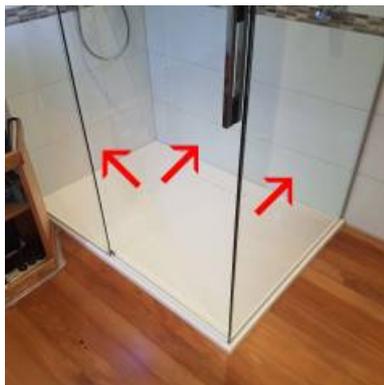
Areas of moisture [Relative moisture readings of concern were found in the area, it is not uncommon for there to be some form of moisture behind the tiles in a tiled shower or when a shower is above a bath in a tiled area. This is usually from moisture getting absorbed through the grout lines or poorly siliconed junction points. The grout lines can be sealed with grout sealer to slow down moisture absorption but it will not completely prevent it, this is an ongoing process that needs to be re-applied regularly to maximise its effectiveness. These tiles should have a water proofing membrane installed behind them, this is done before tiling. A certificate of guarantee for both the application and product should have been supplied by the installer. Make sure to view and obtain a copy for your future warranties.](#)

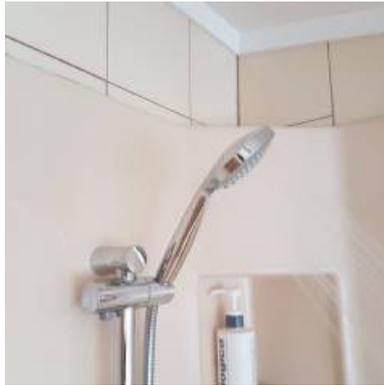
Hand held shower rose, Single mixer, Good water pressure.

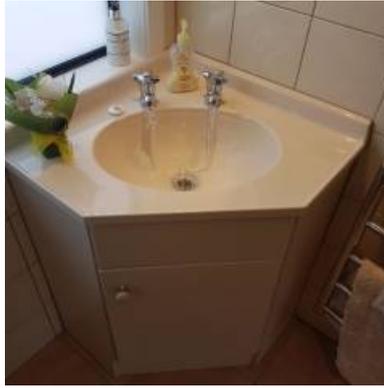
Vanity Unit General: 1 unit, Draining well without blockages, Good Condition. Draining well without leaks or blockages.

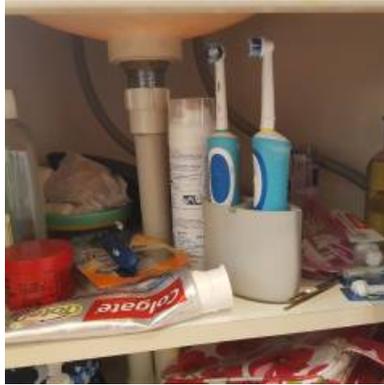
The hot and cold water feeds to this area are Modern PVC Plumbing The waste pipe in this area is modern PVC.

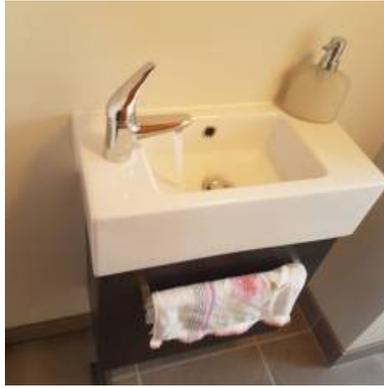
1 unit, Draining well without blockages, Excellent condition, well secured to wall and sealed along the wall junction if needed. Draining well without leaks or blockages.

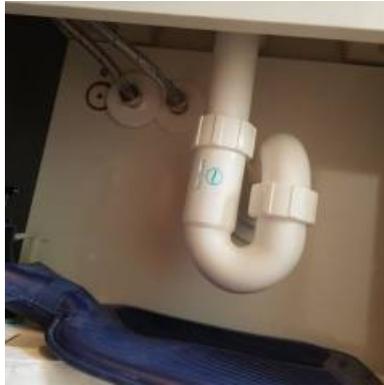
Flexi hose installed here. No plumbing running in the wall cavity was viewed, the plumbing product is unknown unless viewed in the subfloor or ceiling space and this will be noted on in their respective areas of the report.
The waste pipe in this area is modern PVC.

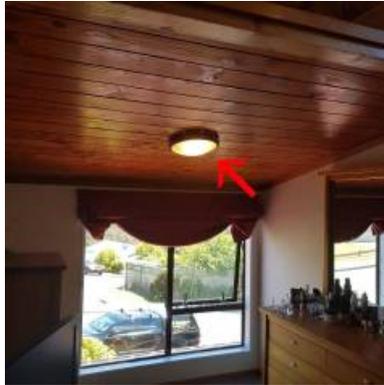
Tested: Tested, working, Dimmer switch installed, [Dimmer, not working.](#)

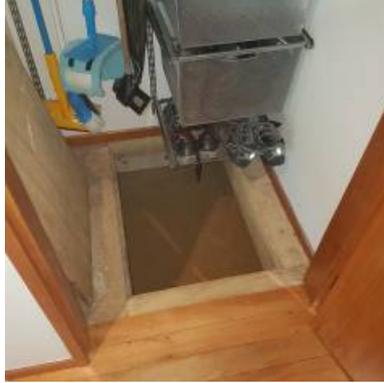
Hallway area.

Reasonable access into the sub floor area. Difficult to gain access into all areas of the sub floor.

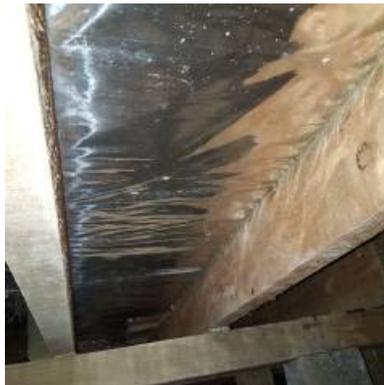
The majority of the soil in this sub floor area is in a dry condition. Some areas of dampness.

No moisture barrier installed, this is not a requirement, but we do recommend one is installed to help prevent rising damp.

The inspector suggests that the foil insulation is removed and modern insulation is installed.

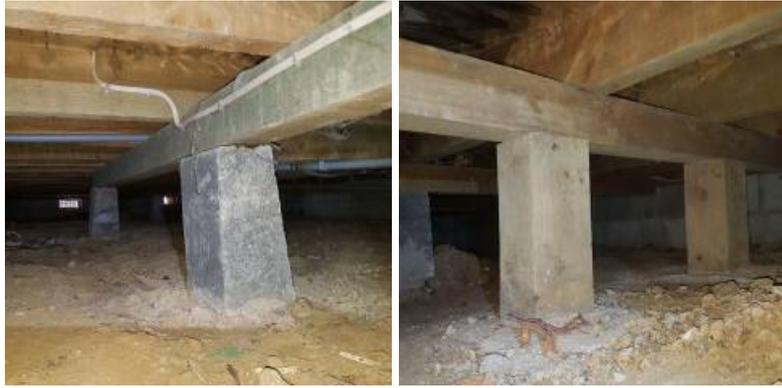
Concrete piles here are in reasonable condition, natural ageing, minor deterioration, but secure. If more in number are required, this will be noted in the sub floor summary area.

Timber piles installed are in good sound condition, **Tie down connections from the pile to bearer are required.**

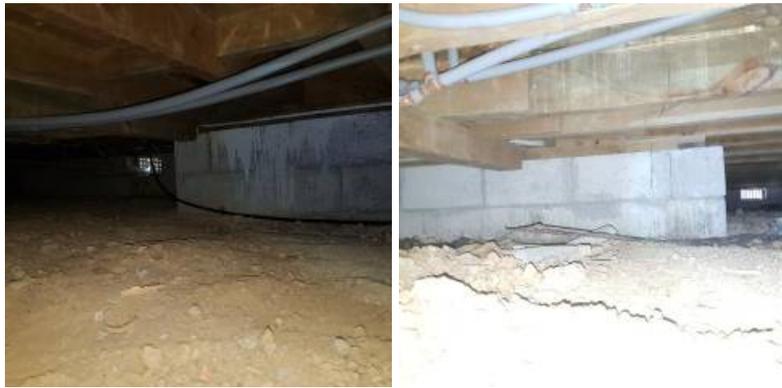
Foundation wall inner is in good sound condition, signs of natural aging but no structural issues evident.

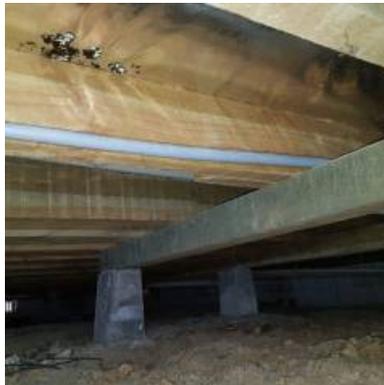
Timber bearers, floor joists are in good sound well connected condition, there is signs of aging and slight movement, adequate numbers of support timber here.

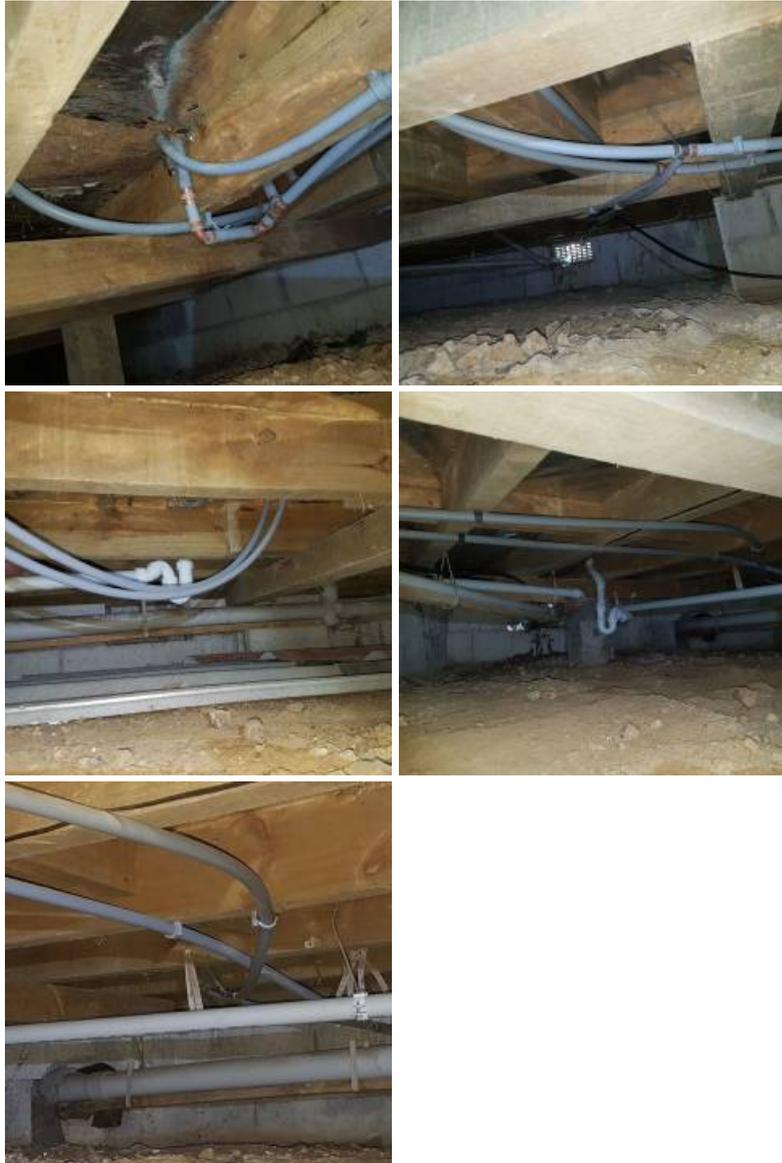
P.V.C, The plumbing evident here was tested and found to be in a good working condition. No evidence of moisture leaks here, maybe signs of old water staining.

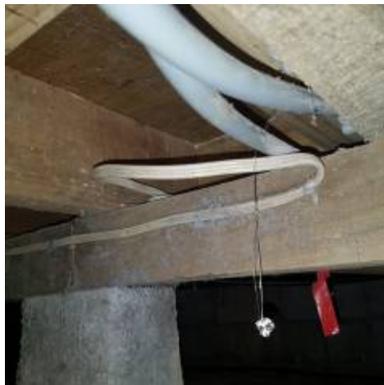
Wiring installed here, The wiring installed here is modern plastic coated. Not well stowed generally, but in reasonable condition.

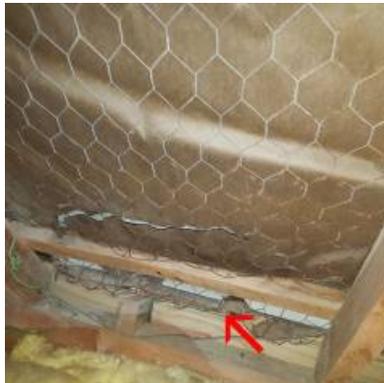
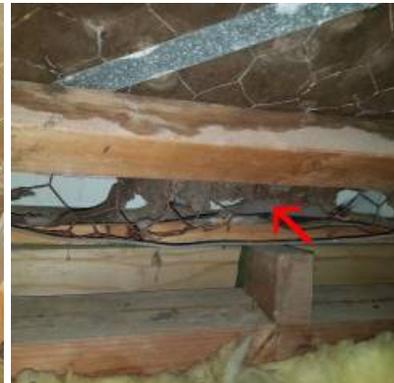
Lining paper, **Remedial required on the roof lining installed. Damaged and requires re-fixing, or re-placing.**

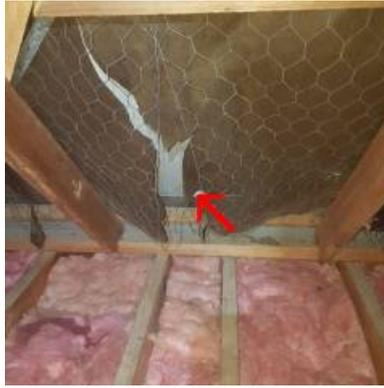
Roofing type

Timber pitched roof installed here, The timber pitched roof is in a reasonable condition. Signs of ageing but no major issues to be concerned about

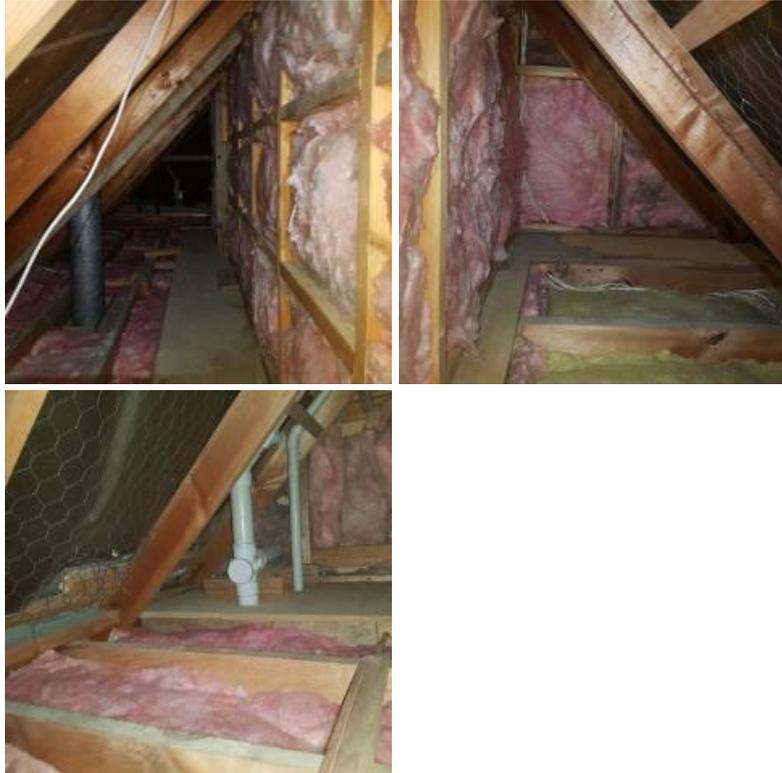
Plumbing

P.V.C, The plumbing installed here, is reasonably well secured, shows signs of ageing, but there is no evidence of any moisture leaks.

Wiring installed here, The wiring installed here is modern plastic coated. Not well stowed generally, but in reasonable condition.

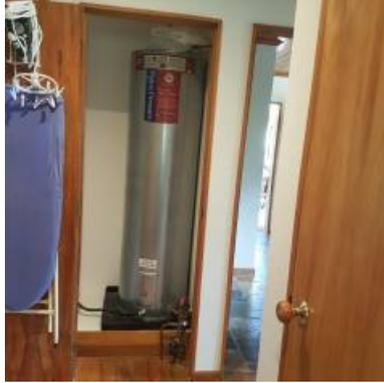
Hallway area.

Electric.

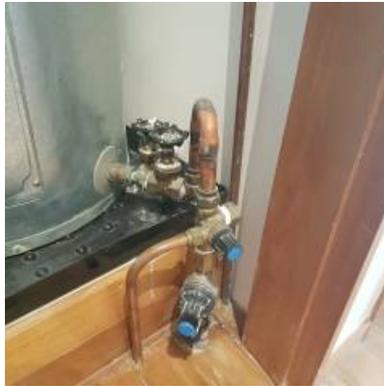
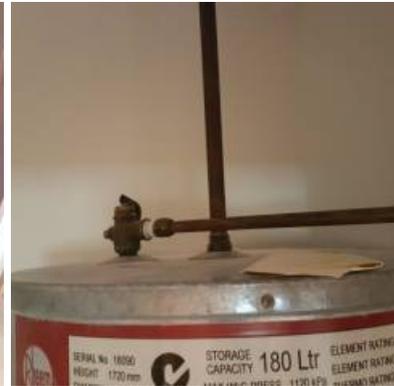
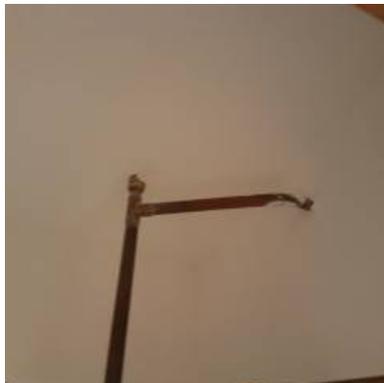
Copper.

Seismic strap not fitted, [Requires a seismic strap to be fitted.](#)

General comments on the cylinder and connections: The cylinder carcass and the connections here are in a good sound condition. No sign of any damage or moisture leaks evident on the day of inspection.
