# Property Inspection Report

***- Habit Blenheim -***

***SAMPLE STANDARD REPORT***

## Inspection Details - Property Inspection Report

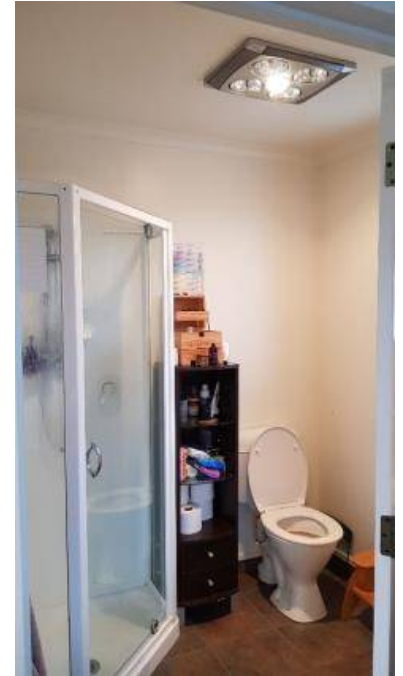
### Bathroom/Ensuite:

*Internal ceiling and wall linings:* Markings noted in areas. Touch ups required.

Remedial attention suggested, Cosmetic upgrade required.

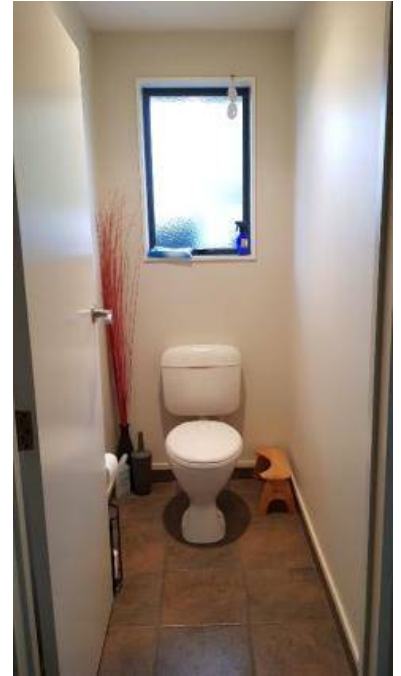
### Toilet:

Minor cracking evident to the plaster joins next to the window, this is a common place where you will get movement, [Cosmetic upgrade suggested.](#)

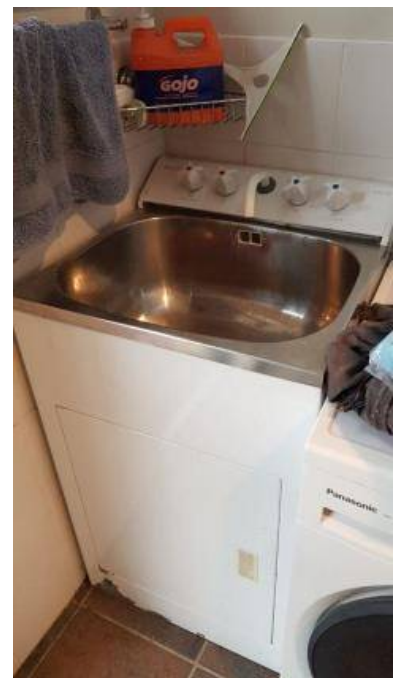
## *Tub:*

Super tub with necessary washing machine connections, Draining well without blockages. Reasonable Condition.
