Property Inspection Report

- Habit New Zealand Limited -

***Sample Report
1960's Weatherboard***

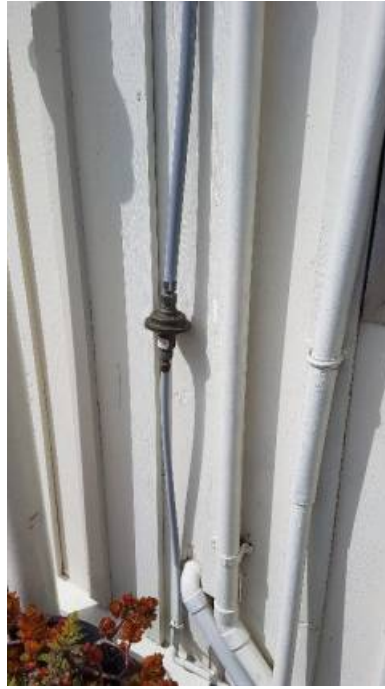
Remedial attention is required by a registered plumber to replace this Grey PVC plumbing as it is no made to be used outside, the UV rays will cause deterioration and corrosion.

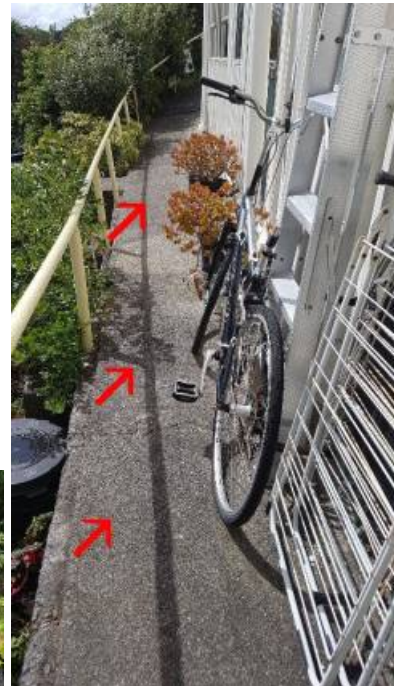
Paths:

Subsidence evident, paths have dropped over time. The inspector suggests better drainage is installed as there is a lot of water run off from the bank above the property.

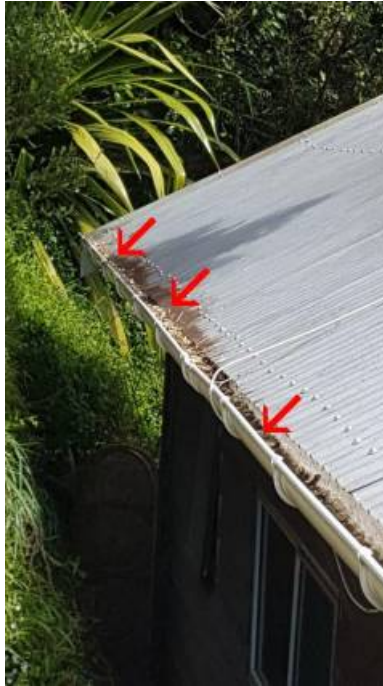
PVC, material in, Reasonable Condition, A thorough internal clean is required. Gutters are blocked with debris and vegetation. This in turn can cause water to back up and overflow into the soffit area and even into the wall cavity in some instances. This needs to be an ongoing maintenance task.

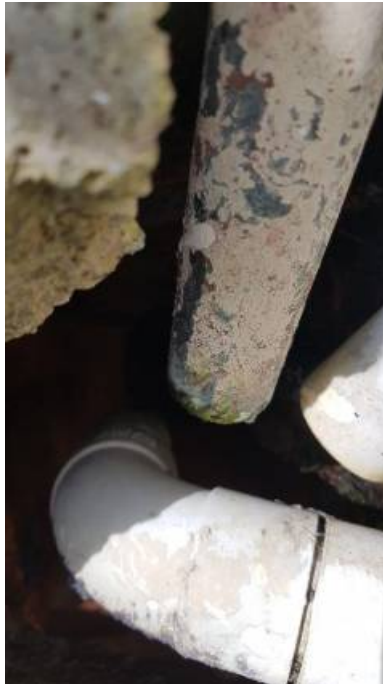
Gully Trap

We recommend all drains are checked with a camera and cleared if need be. On our visual inspection we cannot determine the condition of this pipe work. Blocked drains can occur at any time so it does pay to check, even though there were no signs on inspection.

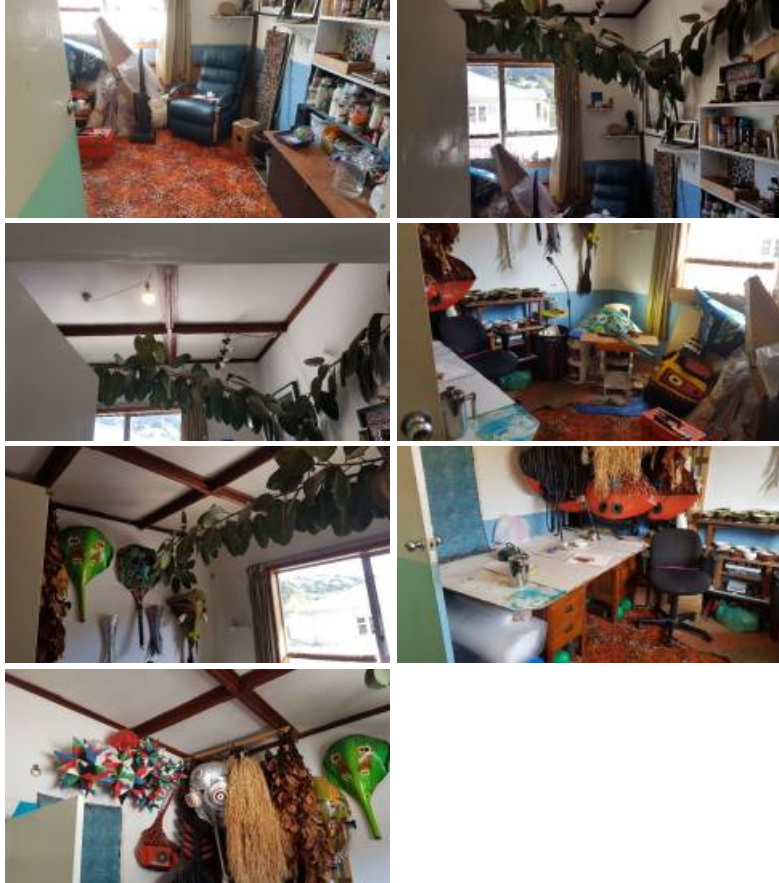
Base linings intact, [Cosmetic upgrade suggested.](#)

No windows in this area, Aluminum frame, Awning, [Remedial attention, Re-fixing, adjustment or replacement of friction stays.](#)

[Deteriorated rubber windows seals evident, recommended replacement to prevent any further moisture ingress and future damage to the window sills and reveals.](#)

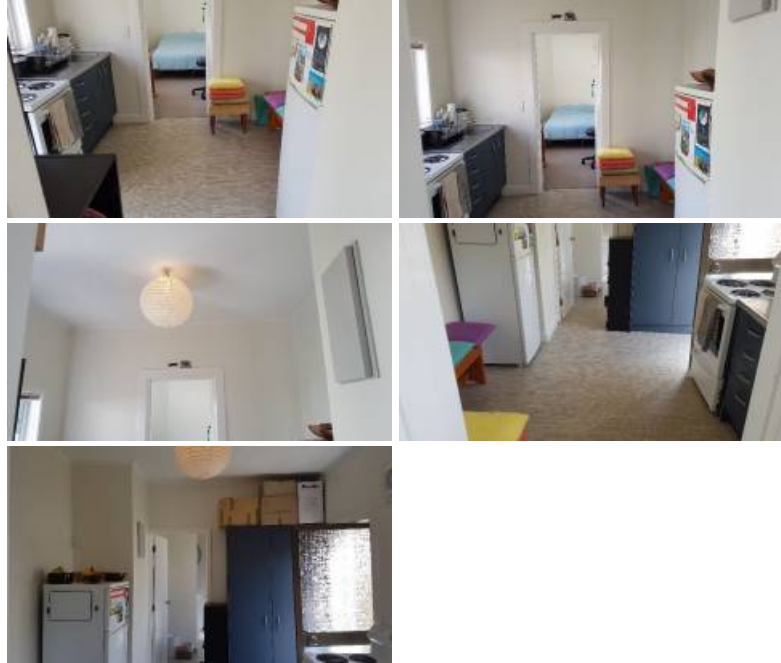
Base linings intact, Cracking evident to the plaster joins this is a common place where you will get movement, Reasonable Condition.

Single glazed, Aluminum frame, Awning, Functions. Remedial attention, Deteriorated rubber windows seals evident, recommended replacement to prevent any further moisture ingress and future damage to the window sills and reveals.

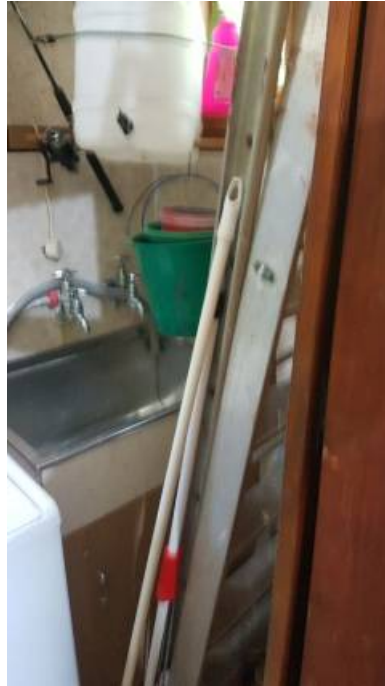
Internal ceiling and wall linings: Base linings intact, Reasonable Condition, [Cosmetic upgrade suggested.](#)

Window sash and function: Single glazed, Aluminum frame, Awning, Functions. [Remedial attention, Re-fixing, adjustment or replacement of window handle.](#)

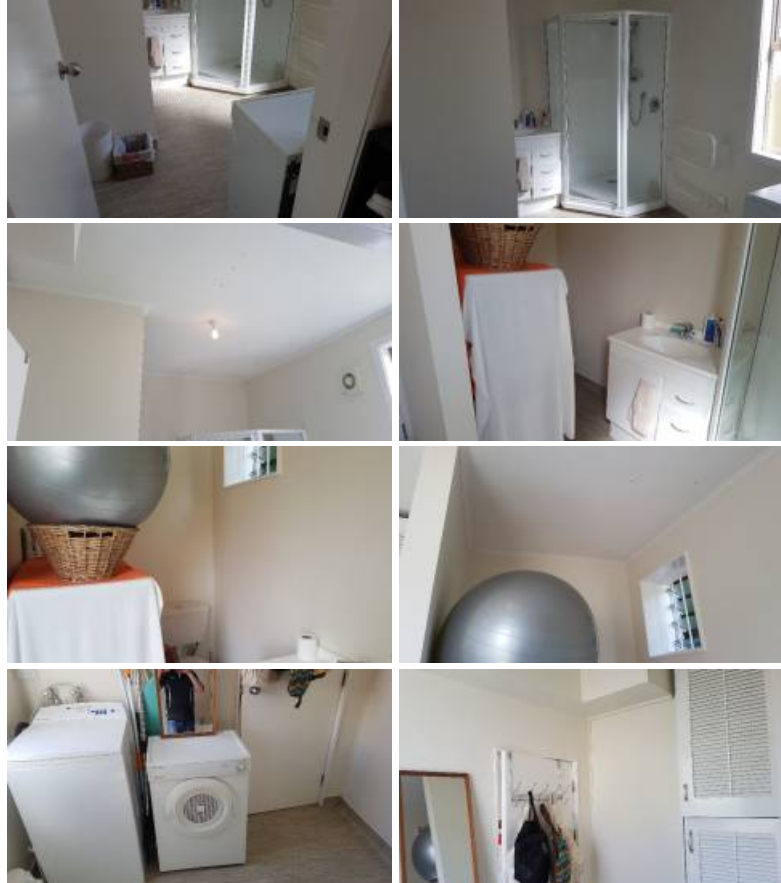
Cosmetic upgrade suggested.

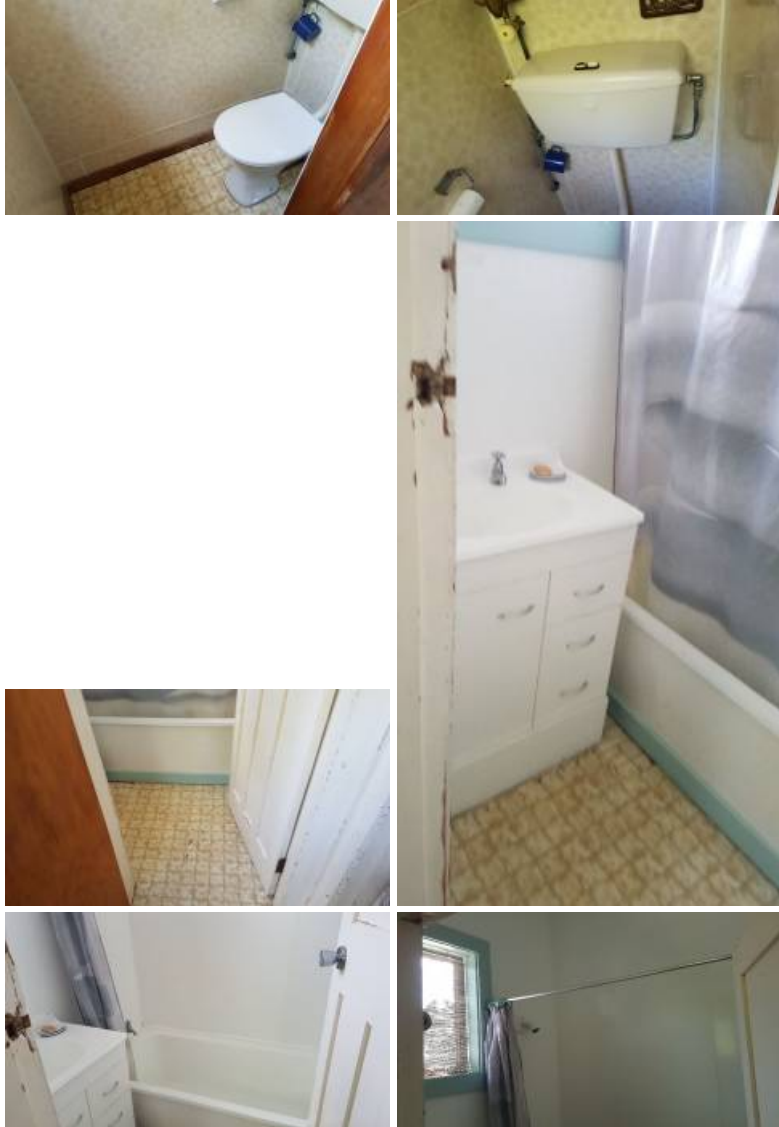
Cosmetic upgrade suggested.

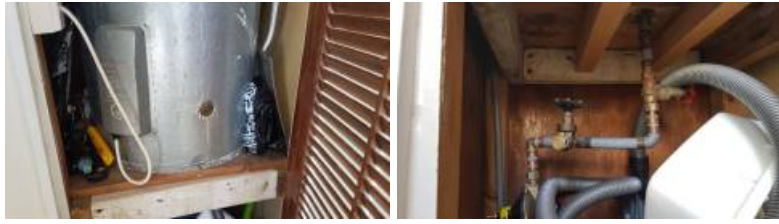
The cylinder carcass and the connections evident appear to be in a reasonable condition. Natural signs of ageing, no sign of any major damage or moisture leaks evident here.
