# Property Inspection Report

**- Habit Whakatane -**

***Sample Report Monolithic***

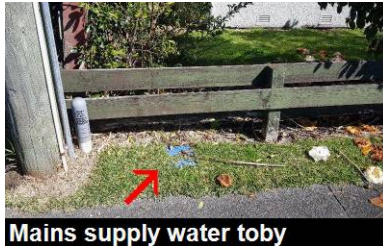
Found at the front of the dwelling.

Mains supply water toby

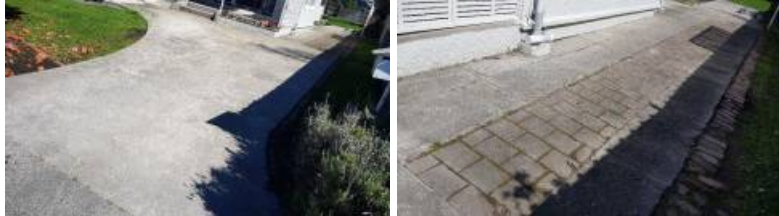
#### Driveway:

Concrete, Reasonable condition, Natural aging and cracking evident.

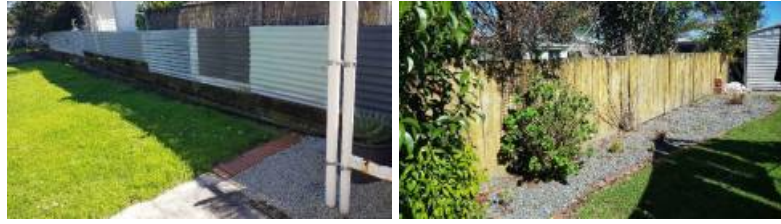
*Paths:*

Concrete, General ageing evident, Remedial attention suggested, Damage evident here. Replacement of the damaged area required.

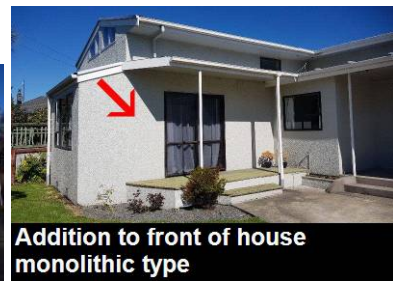
**Addition to front of house  
monolithic type**

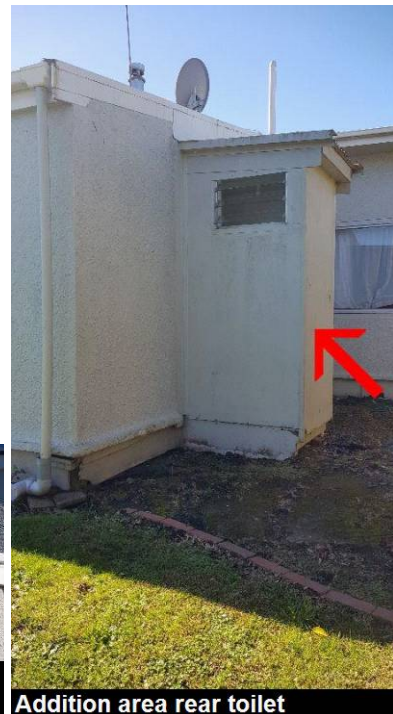
**Addition area rear toilet**

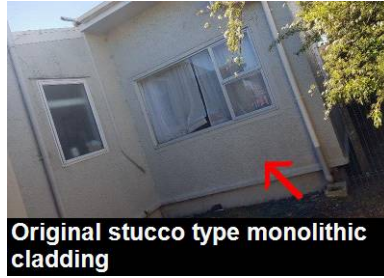
## Cladding Penetrations:

Sealing required around these penetrations through the cladding. No physical evidence of moisture at time of inspection but this is a risk area that requires sealing and monitoring. This area is a potential moisture ingress point, moisture may have already entered this area but on our visual inspection this cannot be seen.

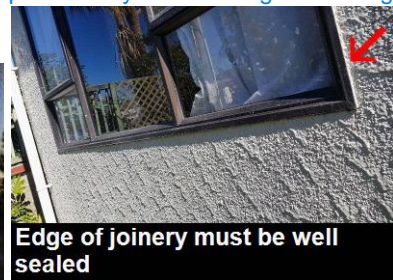
Flashings over windows and door Partial flashings fitted only as required, Reasonable Condition. areas:

**Remedial attention required.** This flashing does not extend past the window head enough to meet current requirements, a licensed building practitioner can carry out this remedial task. These areas are potential moisture risk points. These areas may have leaked in the past causing damage to the wall framing which cannot be viewed on our non invasive inspection. Further investigation is required.

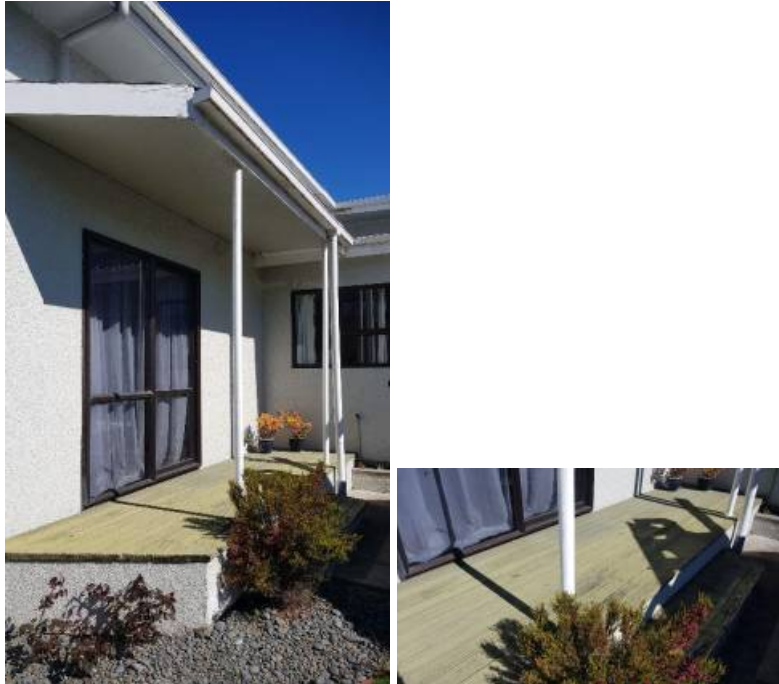
Timber Decking, Timber framing installed, with verandah overhead coverage.

Remedial attention suggested - The deck has been built hard up against the house in this area. This type of construction met the standards and regulations at the time of construction but is known to fail. This can cause damage to cladding, water can get trapped between the timber or other substrates and the cladding causing deterioration of both products. This can also allow water to track through the fixings into the building envelope. This area may have already leaked but we cannot determine if there is any damaged caused on our non invasive inspection. Further investigation is required.

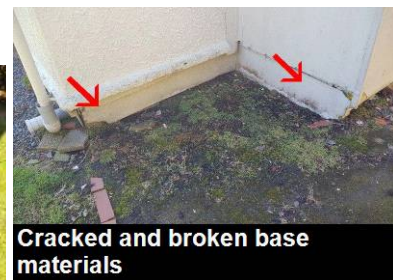
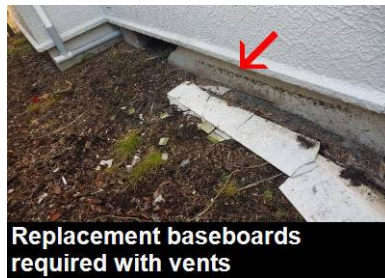
*Base boards:* Compressed fibre cement sheets are installed around the perimeter of the dwelling to enclose the base of the house. Reasonable Condition but some areas of repair required

Remedial attention suggested - Replacement base materials required to some areas.

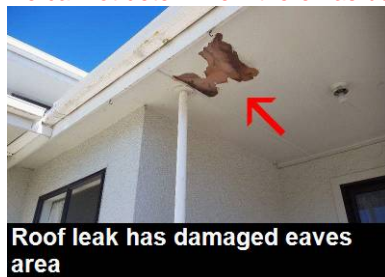
*Areas of moisture*

Further investigation is required in this area, as this is only a non invasive inspection we cannot determine if there has been any damage caused to the wall framing.

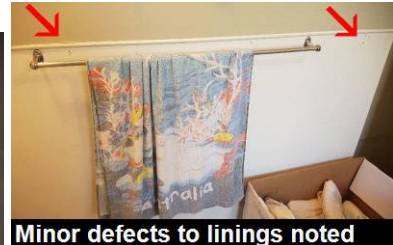
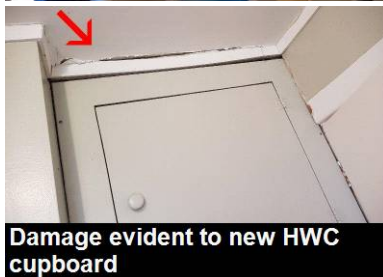
Plaster board base linings intact, Reasonable Condition.

Remedial attention suggested, Damage evident, possible repair of damaged area suggested. Cosmetic upgrade suggested.

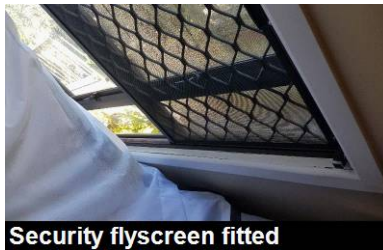
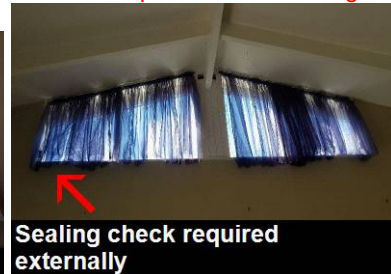
Aluminum frame, Fixed pane, Remedial attention - This window requires attention to exterior where flashing and sealing check are required for weather tightness.

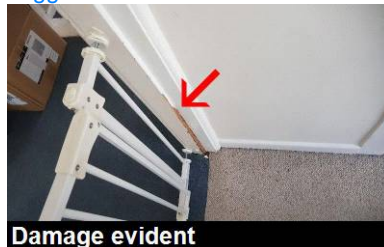
Base materials are in, Reasonable Condition, [Remedial attention suggested, Damage evident, Possible repair of damaged area suggested.](#) [Cosmetic upgrade suggested.](#)

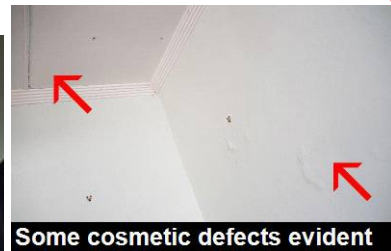
Cosmetic upgrade suggested. Remedial attention suggested - Roof check suggested as there may be minor leaks around older lead head nail fixings.

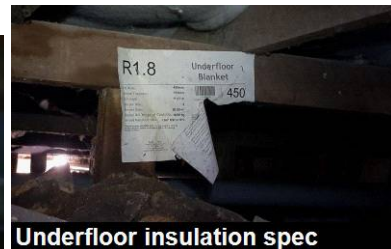
Under floor Insulation professionally installed here.

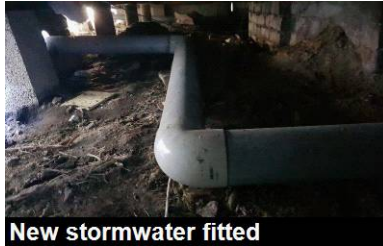
Copper, P.V.C. The plumbing installed here, is in reasonable condition. Signs of ageing and wear. No visible signs of moisture leaks evident here, old water staining evident. Should the plumbing require re-securing, this will be noted in the sub floor summary.
