Property Inspection Report

- Habit Whakatane -

Sample Report Two Storey

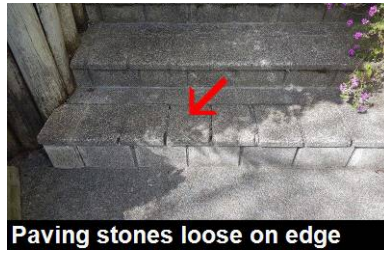
Paths:

Paving installed, General ageing evident. Reasonable Condition.

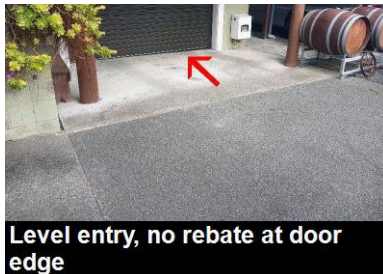
Ground Clearances

Sloping falls but no rebate to garage entry so poor ground clearance here to the top of the finished ground height outside to the finished floor level inside. This type of construction met the standards and regulations at the time of construction but could be subject to potential water entry in heavy wet weather.

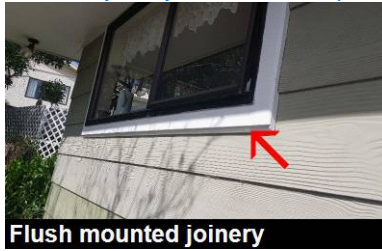
Window Sills & Scribes

Flush mounted. Good Condition. [Be sure to keep the edge perimeter of any flush mounted joinery well sealed to prevent any moisture ingress through the areas,](#)

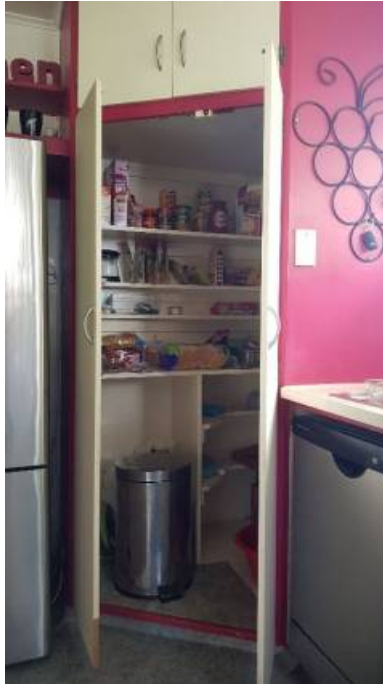
Pantry doors, handles & catches: Reasonable condition, functions adequately, Remedial attention required, Cosmetic upgrade on door areas.

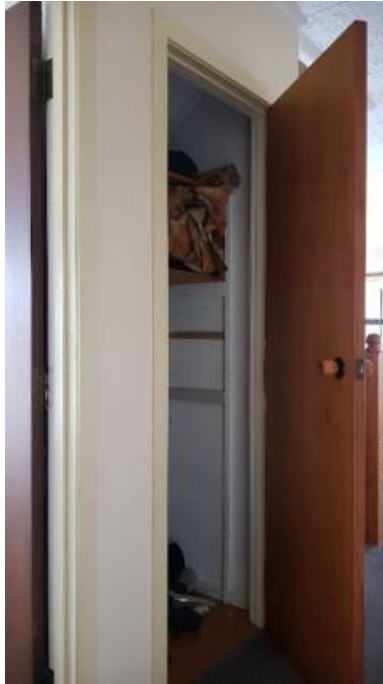
Storage area doors: Hinged door, Reasonable Condition, [Remedial attention suggested](#), [Easing required](#).

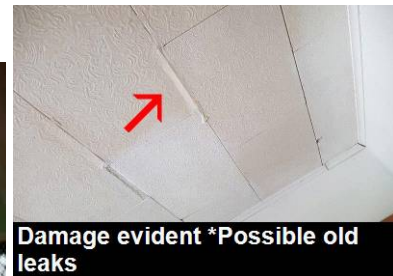
Base linings intact, Remedial attention suggested, Re-fixing of lining or panel, Damage evident, possible replacement of damaged area suggested. Ceiling linings.

Areas of moisture Historical moisture signs evident but no moisture readings of concern were found in this area on the day of inspection. As this is only a non invasive inspection we cannot determine if there has been any damage caused to the framing.

Further investigation is required - Possible old plumbing leaks evident *Recommend licensed builder remove and investigate ceiling area and re-instate any damaged materials.

Remedial tasks listed - Further investigation and repair to damaged ceiling area.

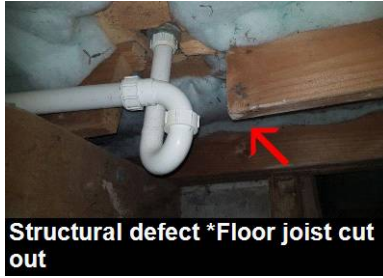
Damage evident - floor joist cut affects structural support under shower.
*Recommend licensed builder create working repair and strengthening to this area.
