# Property Inspection Report

**- Habit New Zealand Limited -**

***One Bedroom Apartment***

<i>Date:</i>	This dwelling was inspected on 14/06/2017. This report refers to findings on that day only.
<i>Time of Appointment:</i>	11:30 a.m.
<i>Inspection For:</i>	This report is for the sole benefit of: Sample Report.
<i>Inspector on this property:</i>	Habit New Zealand Limited.
<i>People on Site:</i>	Sample Report.
<i>Weather:</i>	Fine and sunny.
<i>General Description:</i>	This is a multi story building, the purpose of the inspection was to inspect room 807 only.

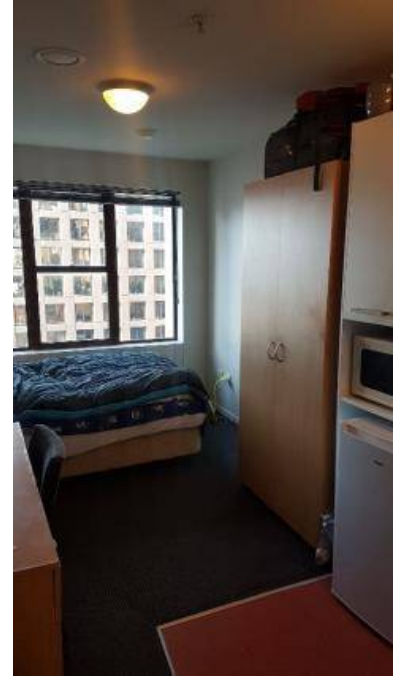
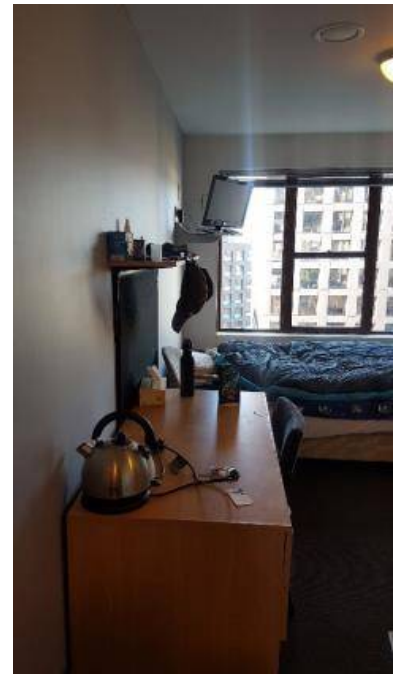
*Internal ceiling and wall linings:* Base linings intact, Reasonable Condition. Slight cracking where a internal partition light weight wall meets the exterior solid concrete wall, this is not a structural concern.

*Floor Covering:* Carpet fitted, Remedial attention suggested. Damage evident, possible replacement of damaged area required.

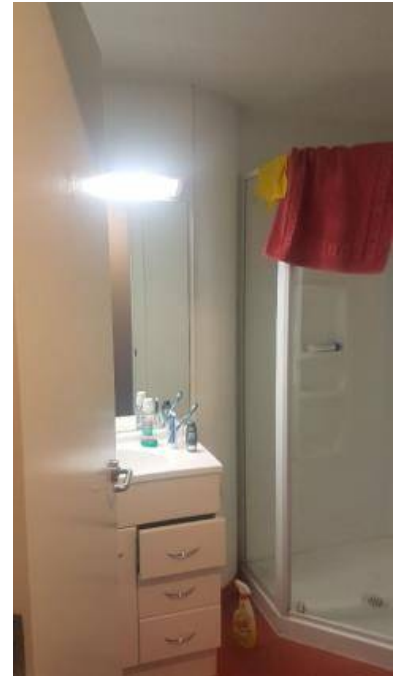
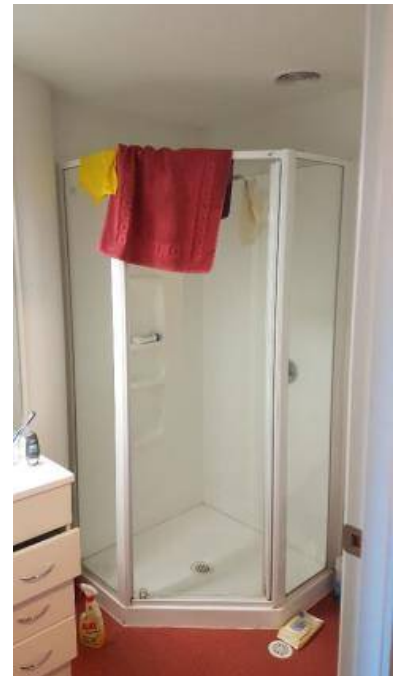
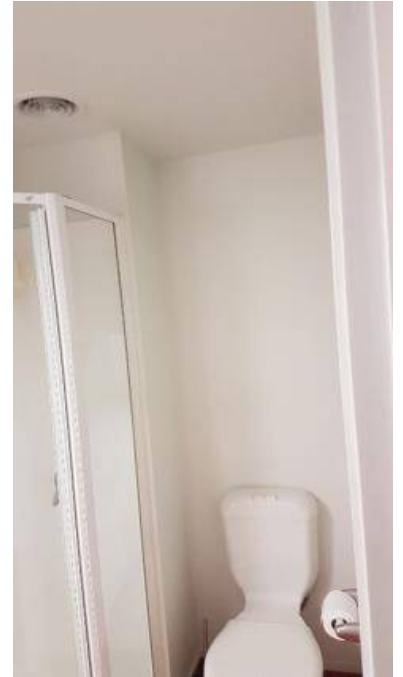
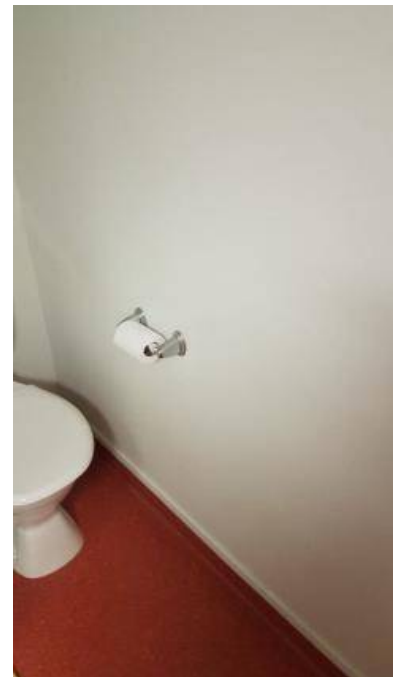
*Internal ceiling and wall linings:* Base linings intact, Good Condition.

*Shower:* PVC linings, Glass surround, Reasonable Condition.
