# Property Inspection Report

**- Habit New Zealand Limited -**

***Sample Report. 1945 Direct Fixed Cladding With Issues***

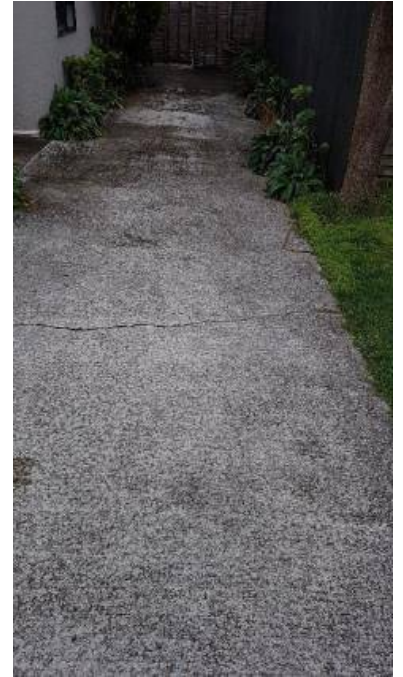
*Driveway:*

Concrete, Reasonable condition.

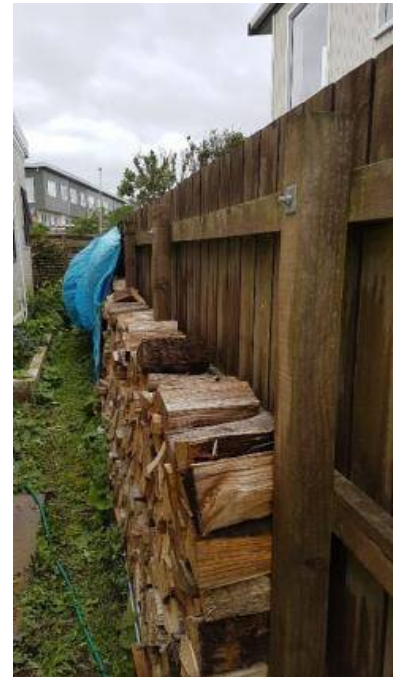
*Fencing General:*

Timber Fencing material in: Reasonable Condition.

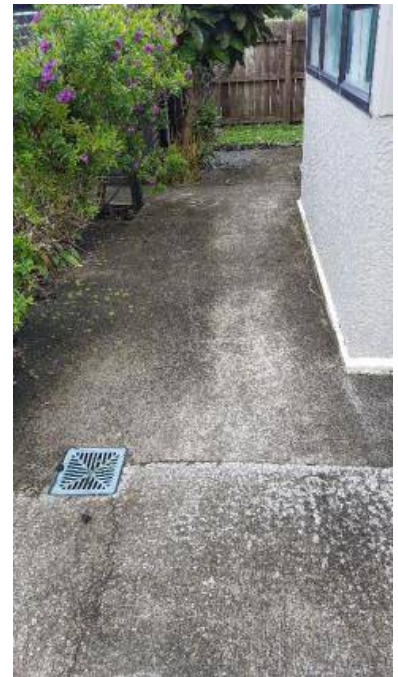
Paths:

Concrete, Reasonable Condition.

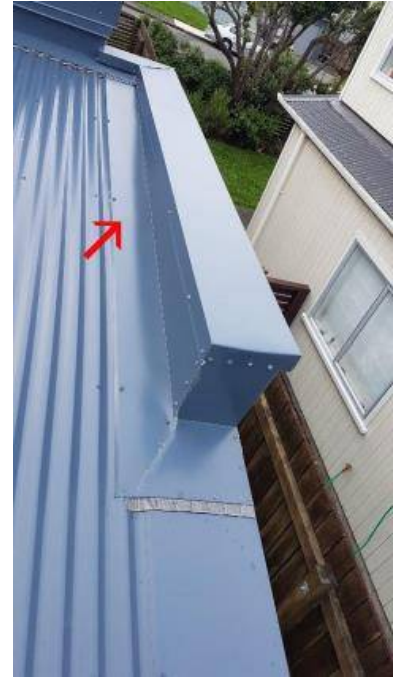
Side roof flashings & ridge capping:

Good flashings, well secured, Material in, Good condition.

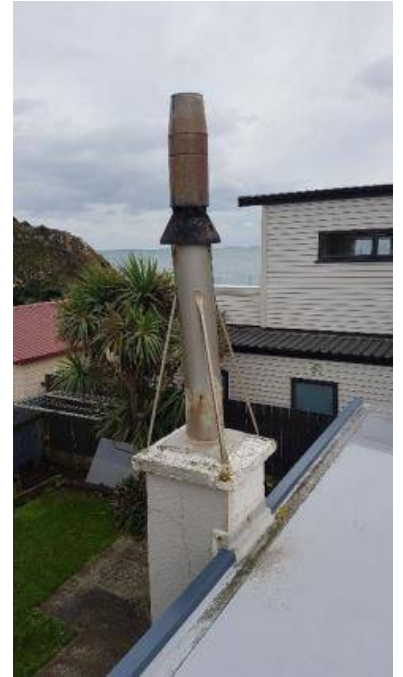
*Chimney:*

Galvanised Iron, Reasonable Condition.

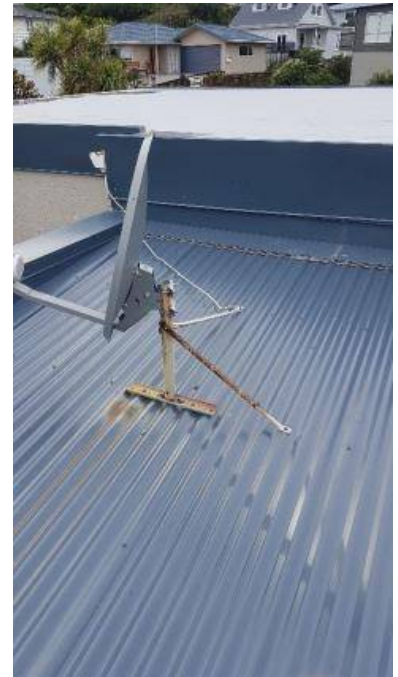
*Aerials:*

Installed.

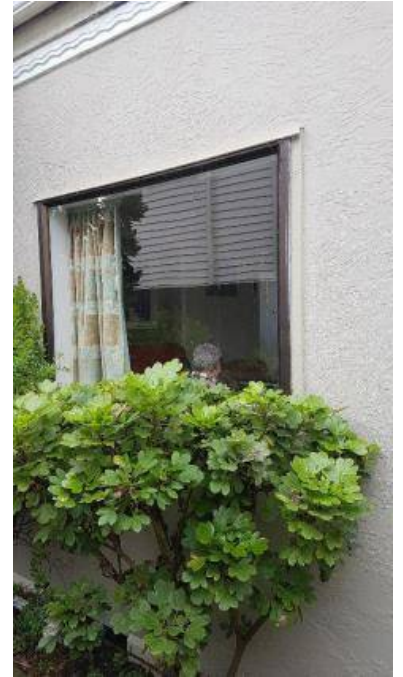
Material in, Reasonable Condition.

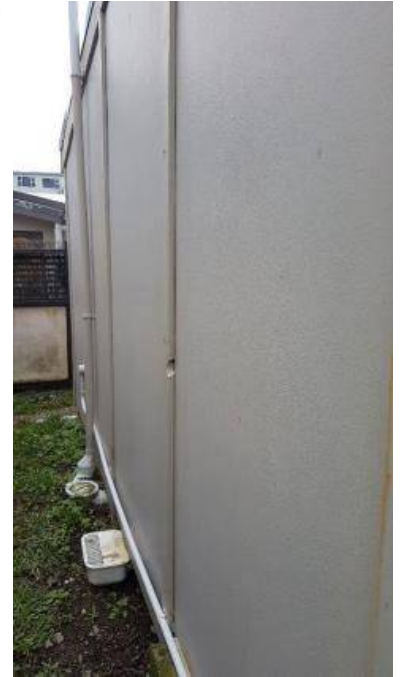
Compressed fiber cement, The cladding may or may not be asbestos, refer to main summary (please read all comments)  
Material in, Reasonable Condition.

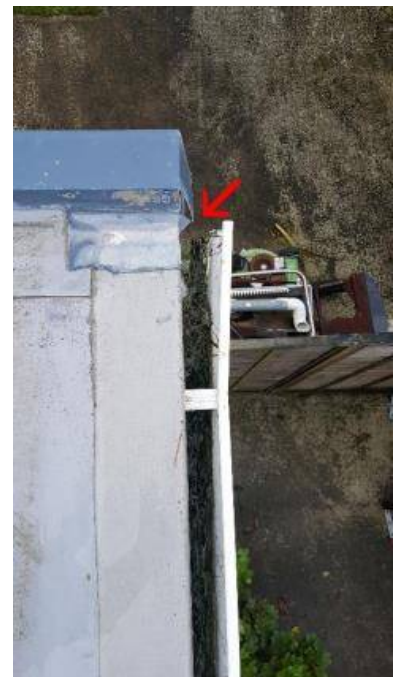
## Guttering:

PVC, Remedial attention suggested, Re-fixing of guttering area required.

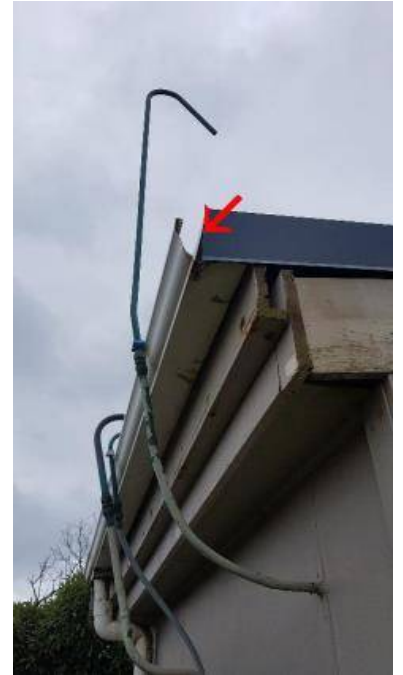
Remedial attention suggested, Recommend replacement on the damaged or excessively aged area.

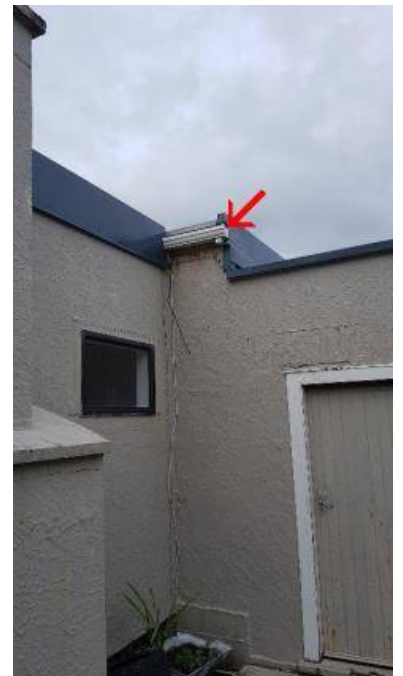
*Downpipes:*

Remedial attention down pipes fitted.

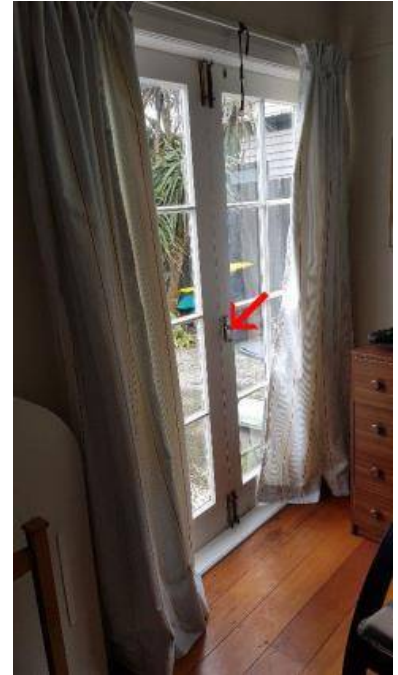
Door types and function standards Functioning Remedial attention suggested, for this room: Catch adjustment required.

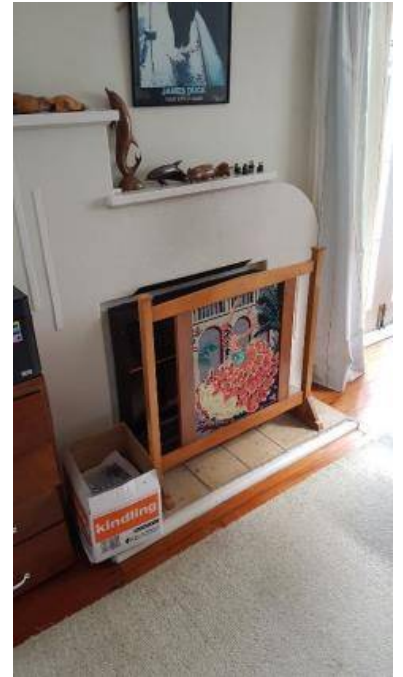
*Heating:* Wood burner built -in. [Not tested or inspected, this is outside of our scope.](#)

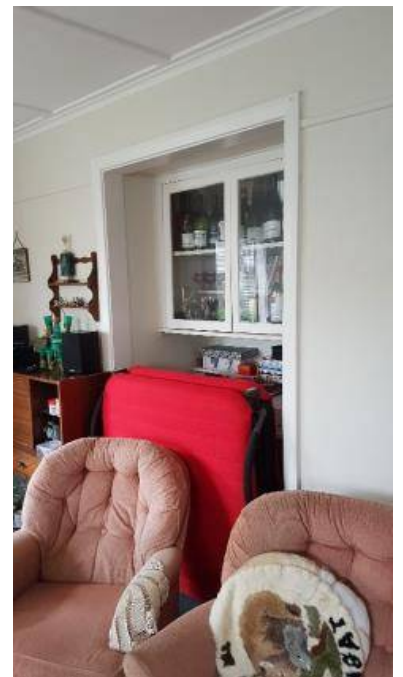
*Storage:* Shelving installed here.

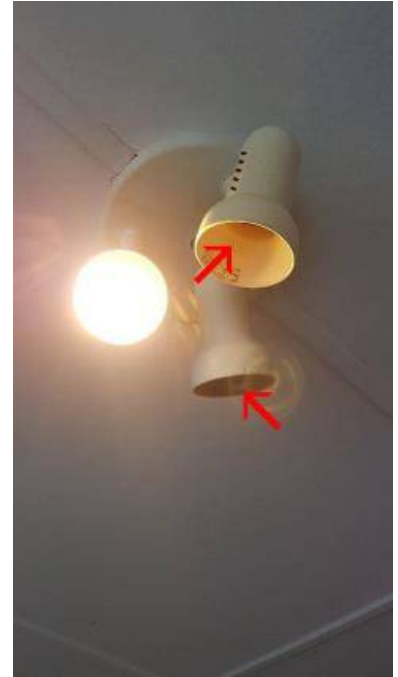
*Tested:* Tested, working, Tested, not working, Bulbs required here.

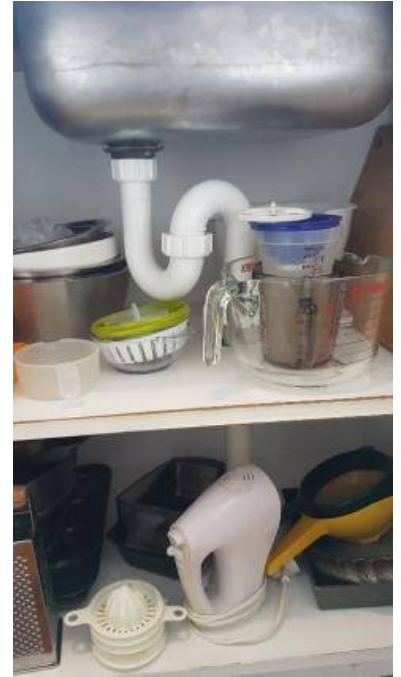
## Plumbing:

No plumbing viewed. Plumbing runs through the wall cavity. The plumbing product is unknown unless viewed in the subfloor or ceiling space and this will be noted on in their respective areas of the report.  
The waste pipe in this area is modern PVC.

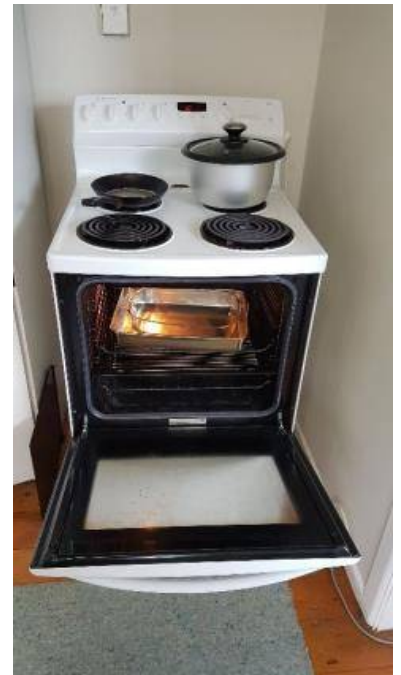
## Oven:

Modern conventional type, Tested, working. **Be aware thermostats are not checked. This is a specialised inspection which we do not carry out. We simply check if the oven heats up or not.** Good condition.

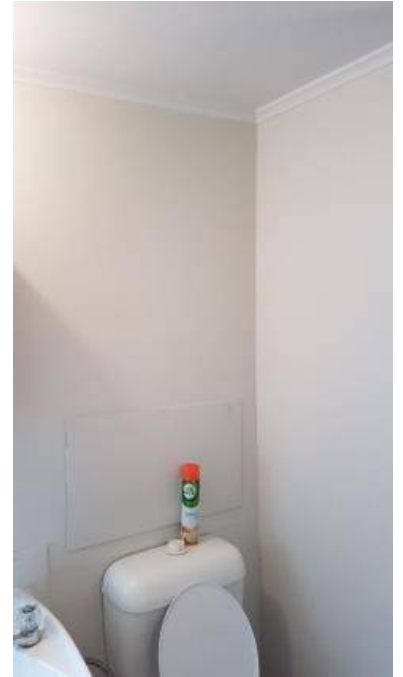
*Internal ceiling and wall linings:*

Remedial attention large cracking to wall linings, subsidence evident, further investigation by a structural engineer is required.

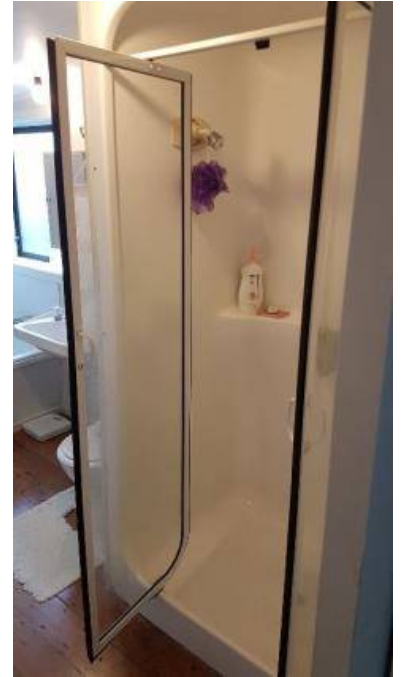
Shower:

PVC linings, Reasonable Condition.

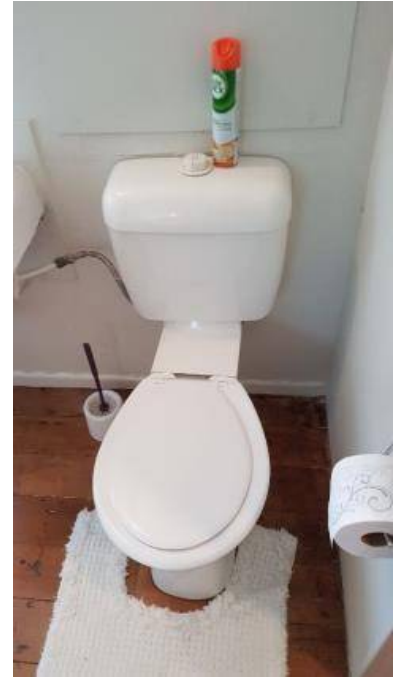
*Toilet Cistern:*

Double flush plastic cistern, **Requires remedial attention, continuously running, a plumber is required to remedy this.**

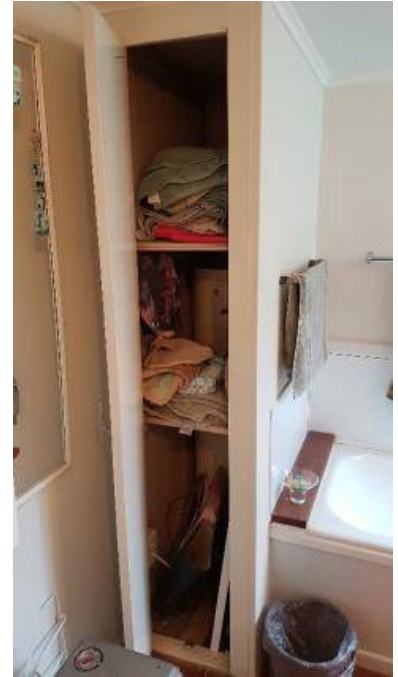
Areas of moisture

Relative moisture readings of concern were found in this area. Further investigation is required in this area, as this is only a non invasive inspection we cannot determine if there has been any damage caused to the wall and roof framing.

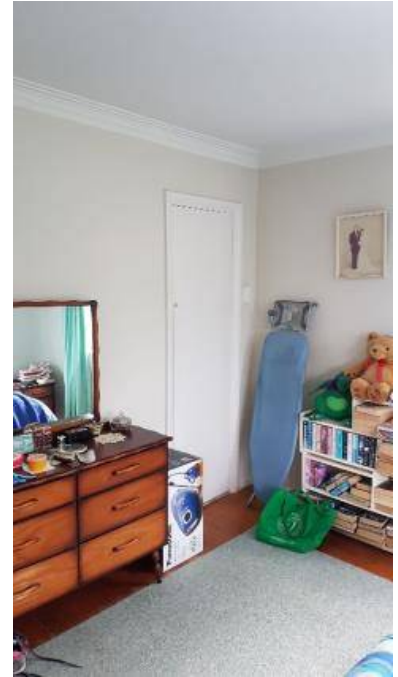
*Internal ceiling and wall linings:*

Remedial attention suggested. Wallpapers lifting and numerous areas due to leaks.

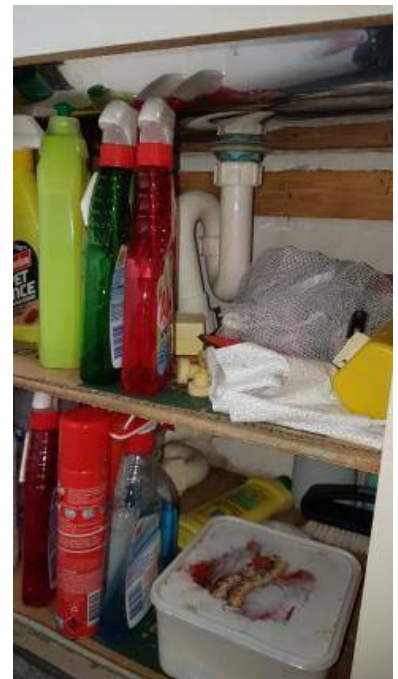
No plumbing viewed. Plumbing runs through the wall cavity. The plumbing product is unknown unless viewed in the subfloor or ceiling space and this will be noted on in their respective areas of the report. The waste pipe in this area is modern PVC.

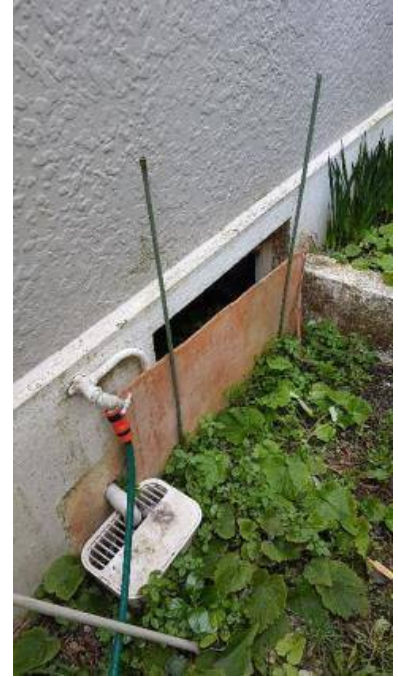
External Area.

Reasonable access into the sub floor area. Difficult to gain access into all areas of the sub floor.

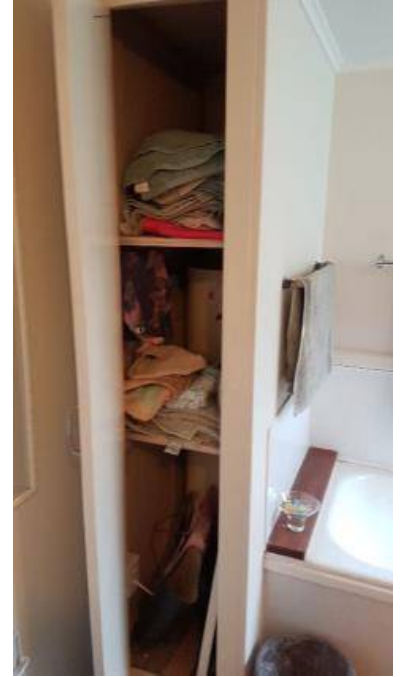
*Location:* Bathroom.

*Method of heating:* Electric.

*Size:* Unknown.

*Pressure:* Low Pressure.

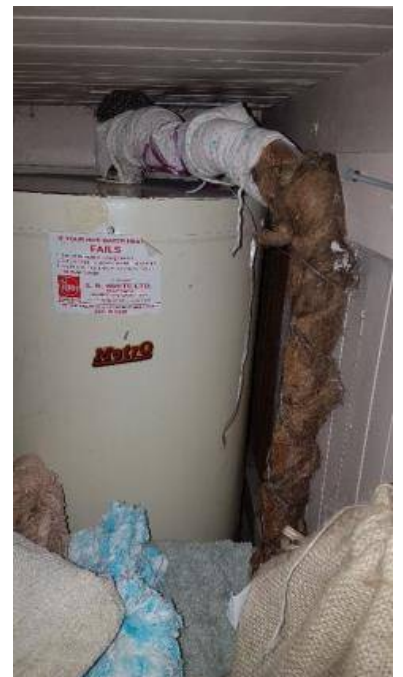
*Plumbing* Copper, The plumbing installed here, is reasonably well secured, shows signs of ageing, but there is no evidence of any moisture leaks.

*Seismic Strap:* Seismic strap not fitted.
